# FG Home Inspections

## SAMPLE Home Inspection Report

**123 Sample Street**

Inspected on: Mon, Sep 7 2020 at 9:00 AM

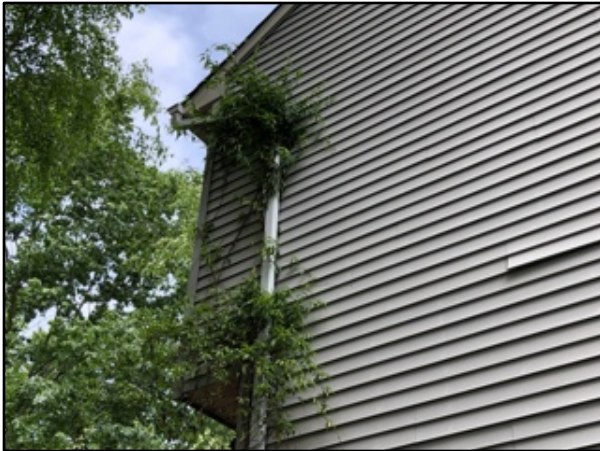
Figure 1-1

Vegetation growing against the house. Vines and ivies can work their way underneath of the siding, introducing moisture, and eventually pull it off of the house. We suggest trimming/removal by a qualified professional.

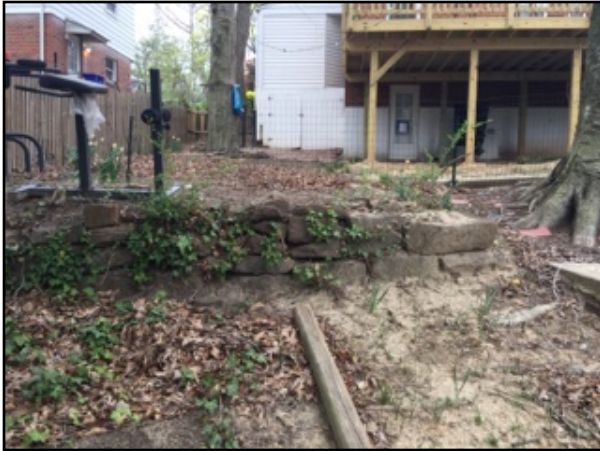
Figure 2-1

Vegetation has grown between the joints of the retaining wall. Roots and/or vines may shift loose masonry over time.

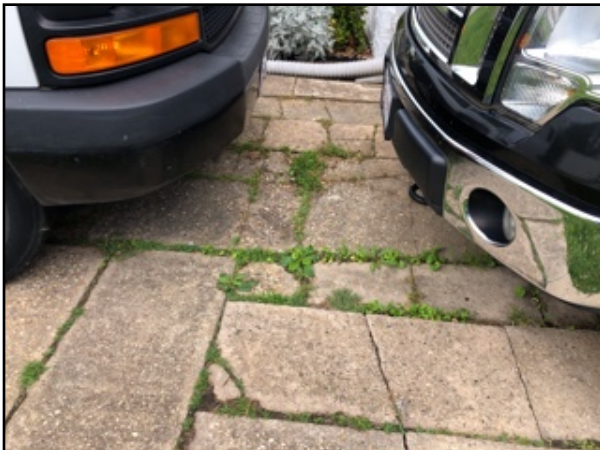
Figure 3-1

Be sure to monitor all cracks in concrete. After water has penetrated, repeated cycles of freezing/thawing will further displace the concrete over time.

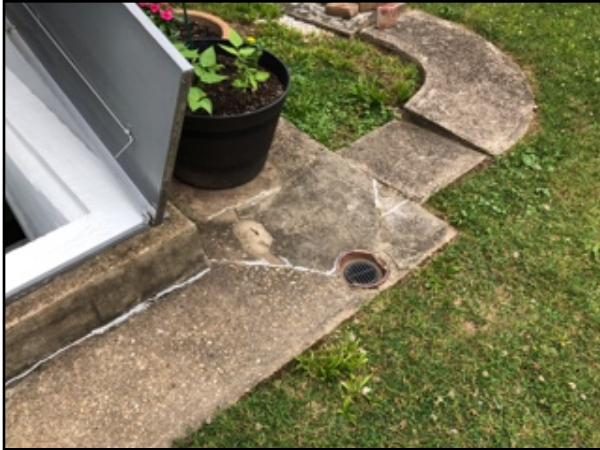
Figure 4-1

Cracked and partially sunken pieces of the concrete walkway create a trip hazard. We suggest monitoring the area during heavy rain/snow.

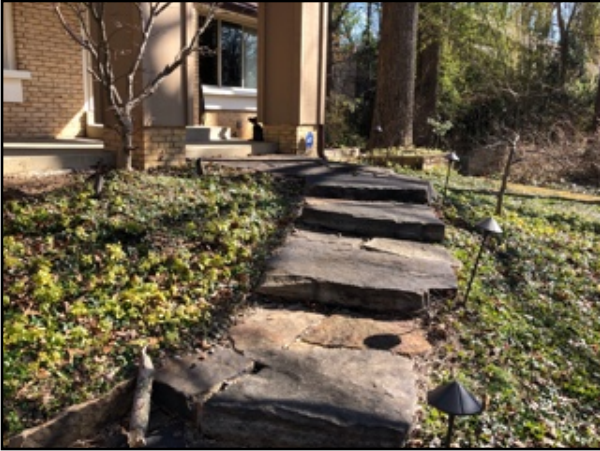
Figure 5-1

Large pieces of flat stone are a way some homeowners create steps in an outdoor setting. There are inherent safety issues, such as rocks possibly becoming slippery when wet, and the lack of a handrail. Be sure to monitor cracks and uneven spots in any walkways. These are opportunities for moisture intrusion, and its resulting damage over time.

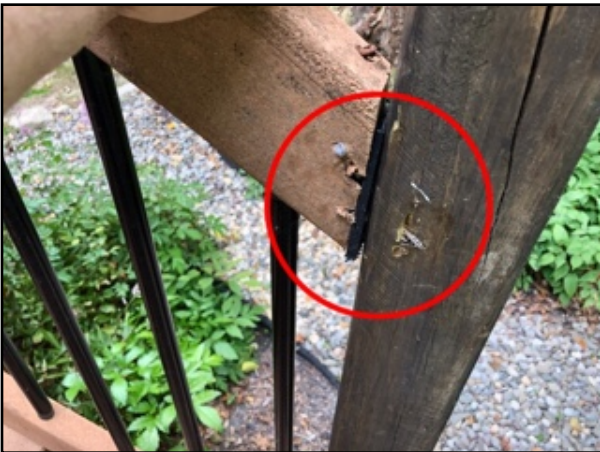
Figure 6-1

Various fasteners have loosened on the handrails of the deck, and others have split/penetrated through on the other side. We suggest repair by a qualified professional.

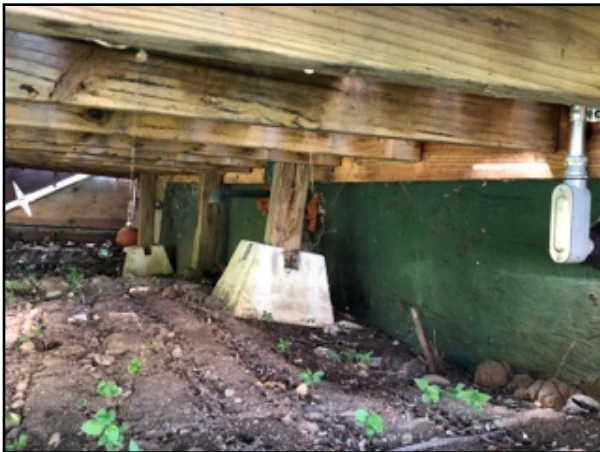
Figure 7-1

Deck blocks should be buried in the surface of the ground a bit, instead of just on top of the ground. Additionally, the ground and deck blocks are not level. We suggest further evaluation and/or repair by a qualified professional.

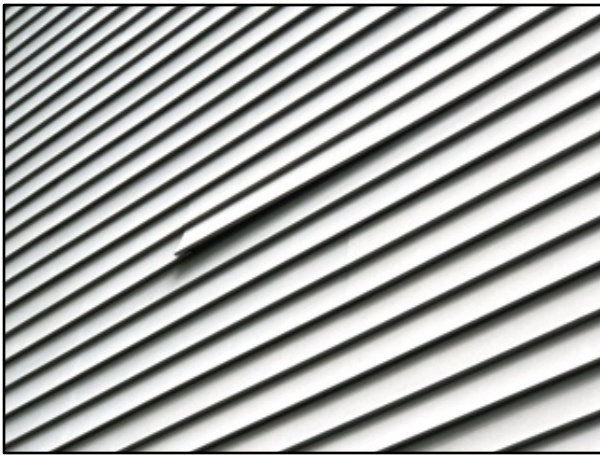
Figure 8-1

Portions of the siding were found to be damaged. This can allow moisture to penetrate. We suggest further evaluation and/or repairs from a qualified professional.

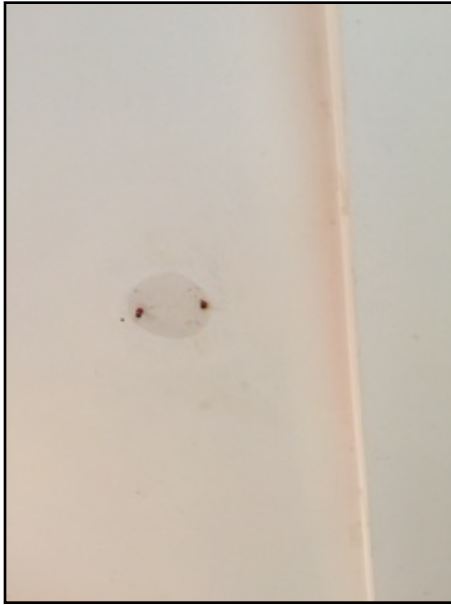
Figure 9-1

Old holes from mounting (flagpole, most likely) should be sealed, to prevent any moisture/pest intrusion.

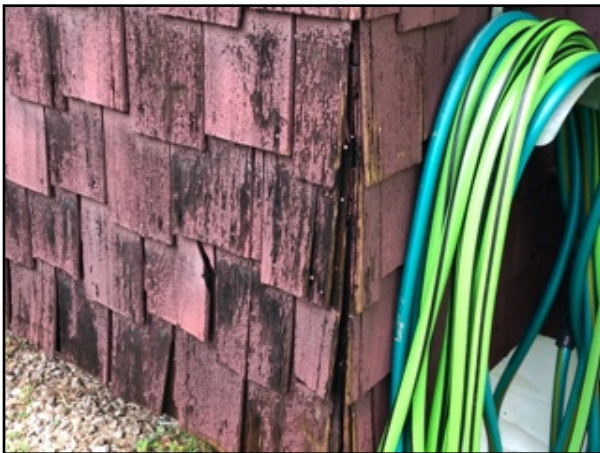
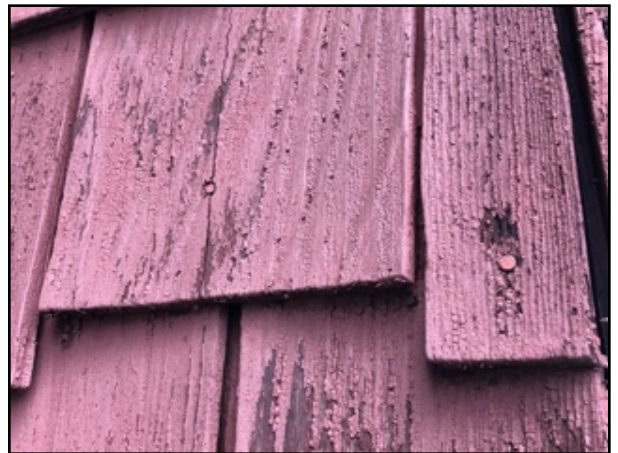
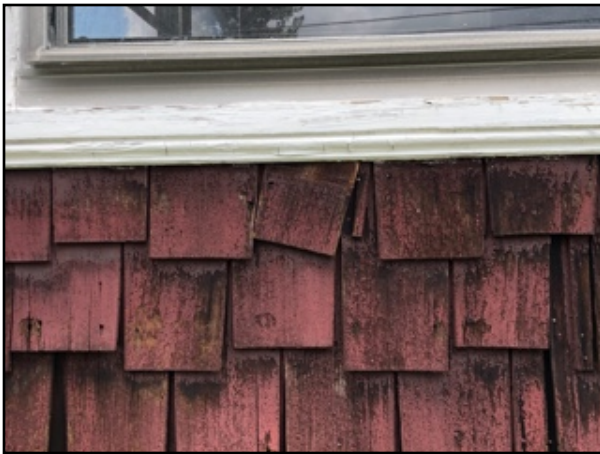
Many of the wood shakes are weathered, damaged, loose, or displaced. There are many opportunities for moisture and/or pest intrusion. We suggest further evaluation and/or repairs from a qualified professional.

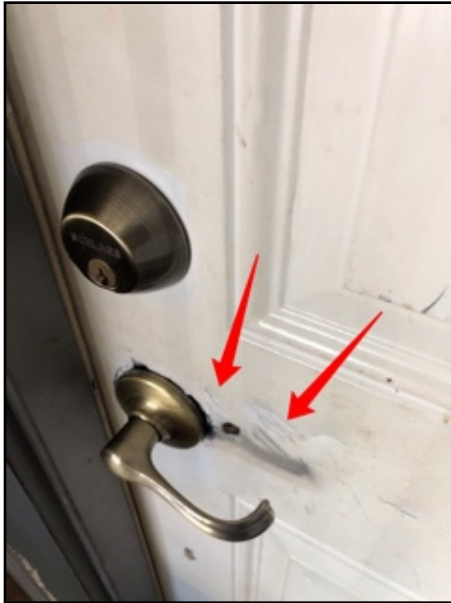
Figure 11-1

Steel door is dented and damaged, but was not suffering any performance issues at the time of inspection. Be sure to periodically monitor/inspect the door to ensure best performance in the future.

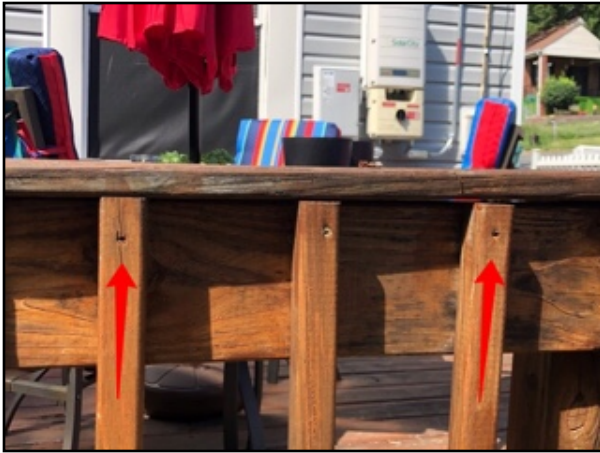
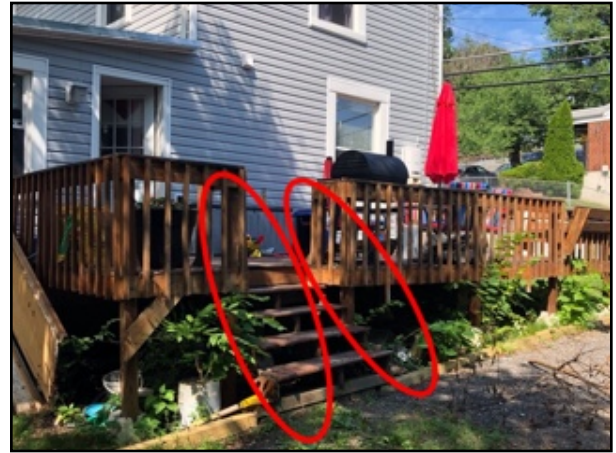
Some fasteners have loosened, or are missing. There is no railing on the back deck stairs. Stairs with 4 or more risers should have a handrail.

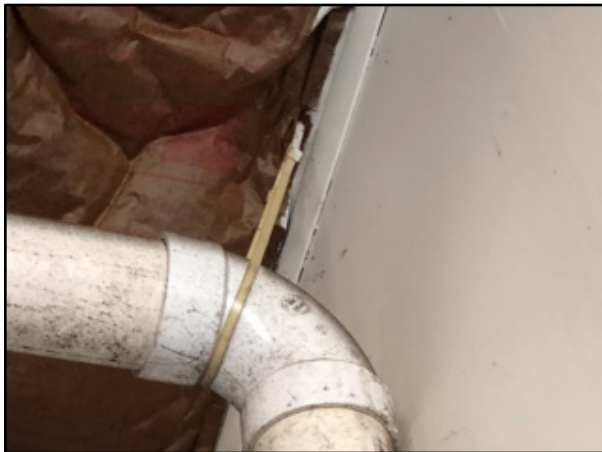
Figure 14-1

Radon mitigation piping is secured with "zip ties", several of which have been penetrated by fasteners. We recommend the replacing of the piping supports with approved strapping/fasteners.

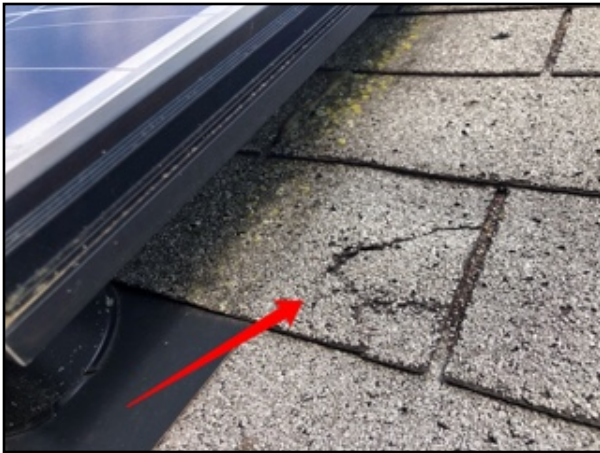
Figure 16-1

These asphalt shingles have been damaged, as indicated. We suggest further evaluation from a qualified professional.

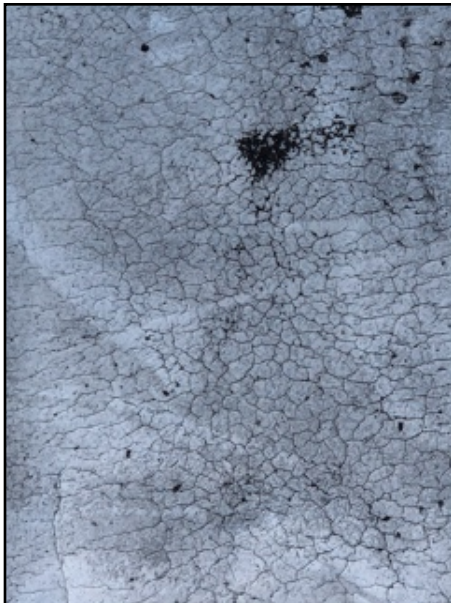
Figure 17-1

Commonly referred to as "Alligator" or "Crocodile" cracking, due to its appearance, minor cracks are to be expected over time on flat roofs. These cracks are points for moisture intrusion, especially around fasteners. We suggest further evaluation from a qualified professional.

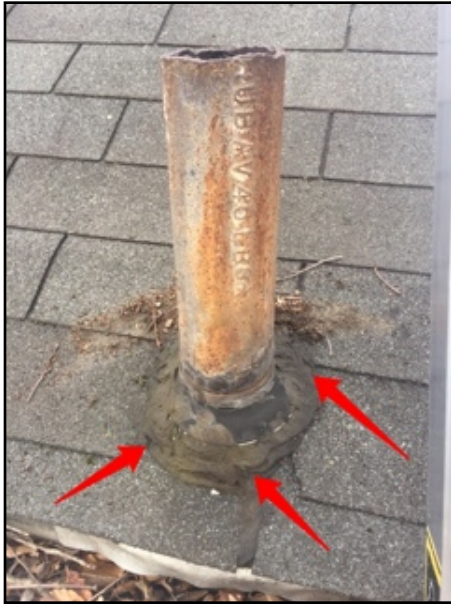
Figure 18-1

The seal around the cast iron vent penetration was not done in a professional manner. The seal around the PVC vent penetration is weathered and worn. In both cases, there is ample opportunity for moisture intrusion. We suggest further evaluation and repair from a qualified professional.

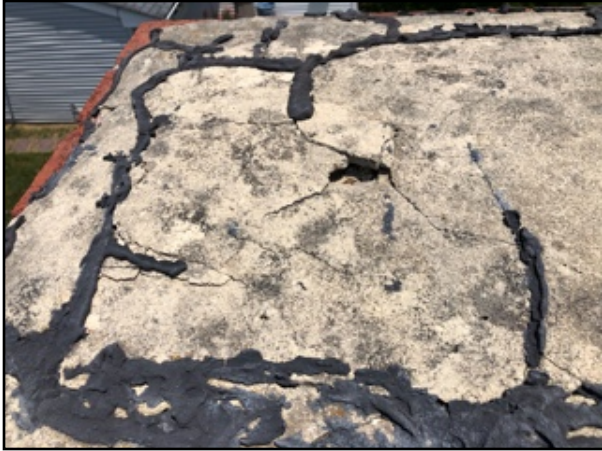
Figure 19-1

Portions of the chimney cap have cracked, chipped, and deteriorated. Previous repairs were made, but new cracks have started, and existing cracks have worsened. We suggest further evaluation from a qualified professional.

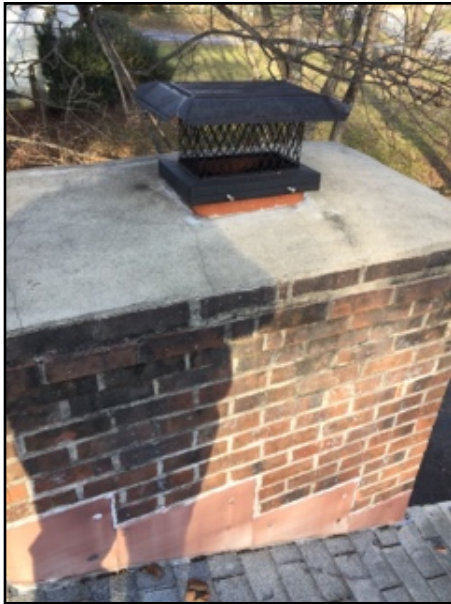
Figure 20-1

This chimney cap is in generally good condition, but some small cracks have begun to develop. We suggest further evaluation from a qualified professional.

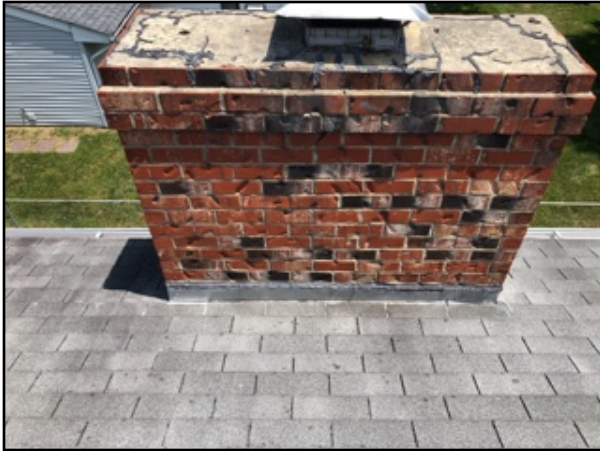
Figure 21-1

Chimneys over 30" wide should have a cricket flashing installed, to prevent moisture intrusion. We suggest further evaluation from a qualified professional.

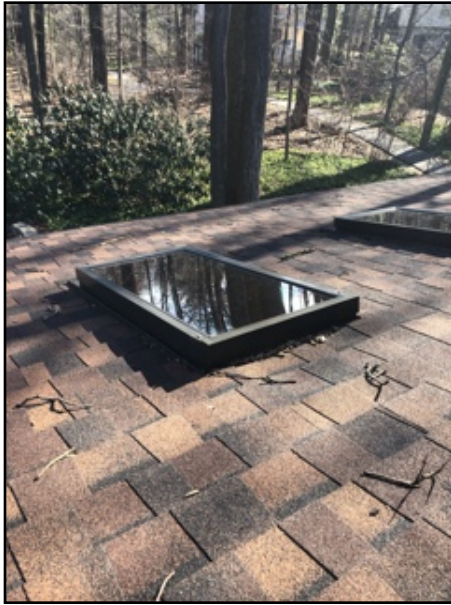
Figure 22-1

While the new roofing installation looks great, it appears that the skylights have fallen victim to previous water damage. No excessive moisture levels detected. Suggest monitoring, because most skylights leak, eventually...

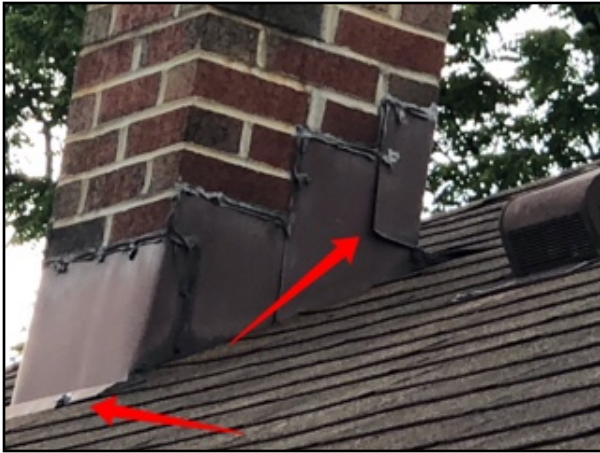
Figure 24-1

Some pieces of metal flashing are not sitting flush against the chimney. This is an opportunity for moisture intrusion. Many of the seals have not been done in a professional manner, and a fastener is exposed. We suggest further evaluation and/or repair from a qualified professional.

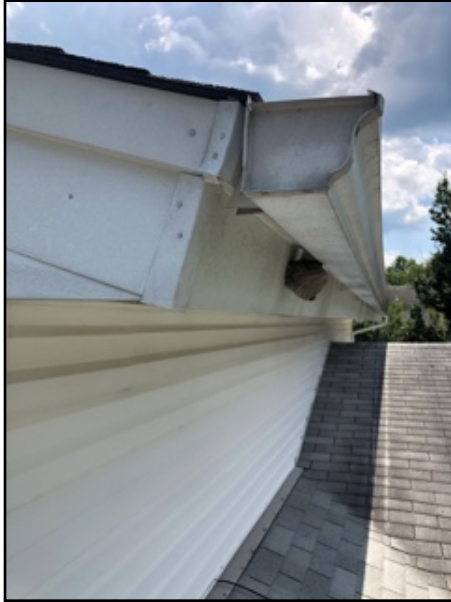
Figure 26-1

Hornet nest found on the NW corner of the home. We suggest removal by a qualified professional.

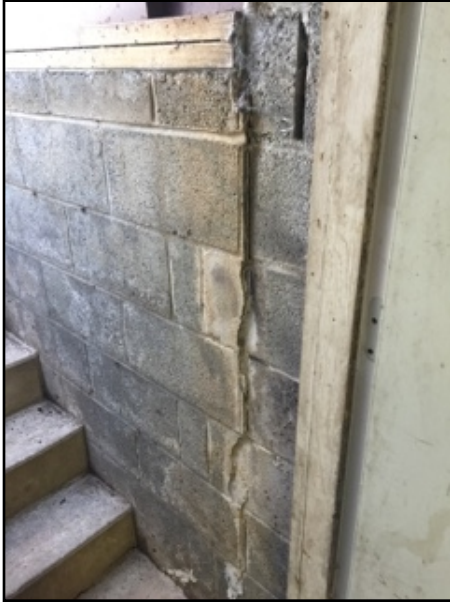
Figure 29-1

The concrete block masonry has cracked in the areaway entrance to the basement. We suggest further evaluation from a qualified professional.

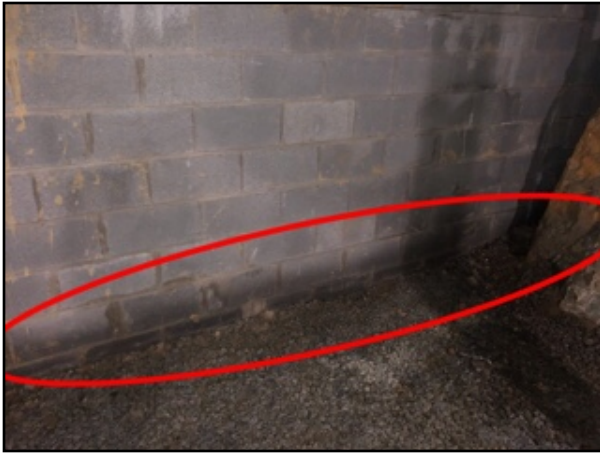
Figure 30-1

In this photo, you can see the excessive moisture levels in the dark color of the concrete block. In this particular home, the sump pump nearby was disconnected, and likely contributed to the high moisture content.

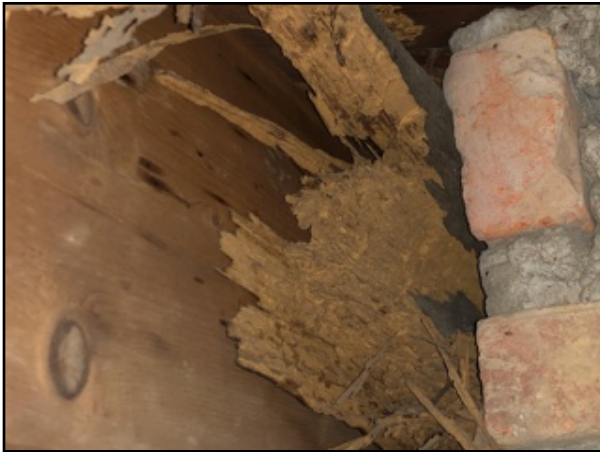
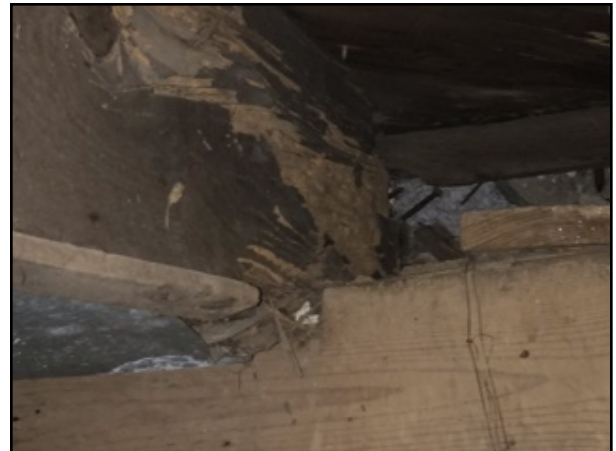
When Wood Destroying Organisms (WDOs) cause damage, it's double the headache. First, you have to hire an exterminator, then you have the repairs to take care of. We suggest further evaluation from a qualified pest professional, and a qualified contractor for repairs.

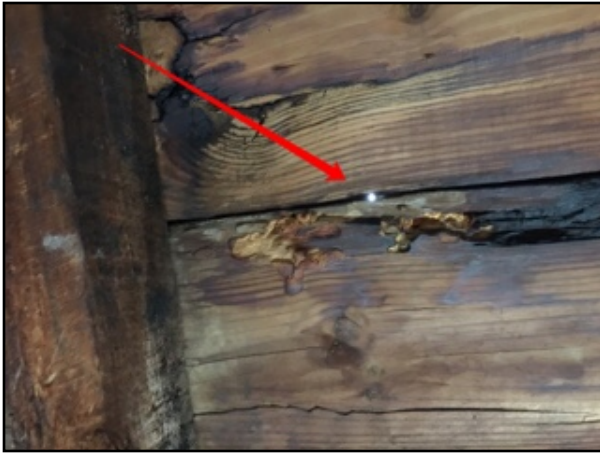
Figure 35-1

If you look closely, you can actually see daylight through the gaps in the wooden planks. This is where a nail was driven, and over the years, loosened and detached. This is certainly a source of moisture intrusion that has led to the water stains. We suggest further evaluation and repairs by a qualified professional.

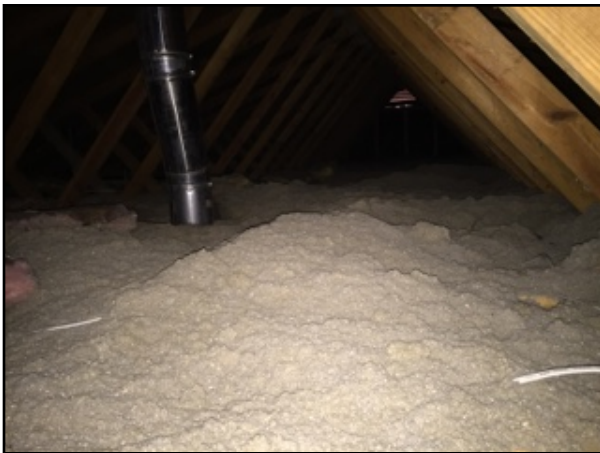
Figure 37-1

Some of the loose, blown-in insulation has been disturbed by tradespeople. Ensure an even cover for even insulation.

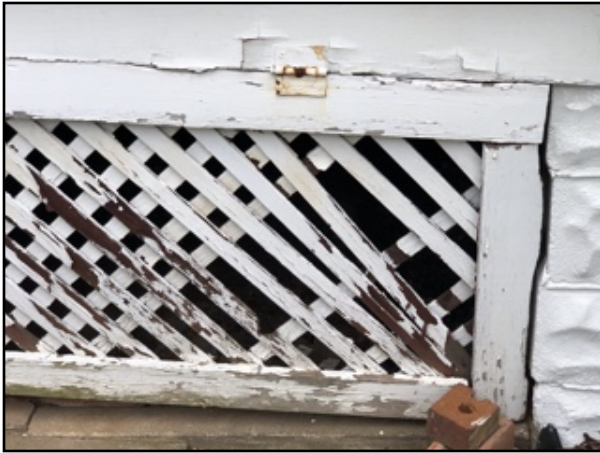
Figure 39-1

Lattice on crawlspace access is damaged. We suggest repairs by a qualified professional.

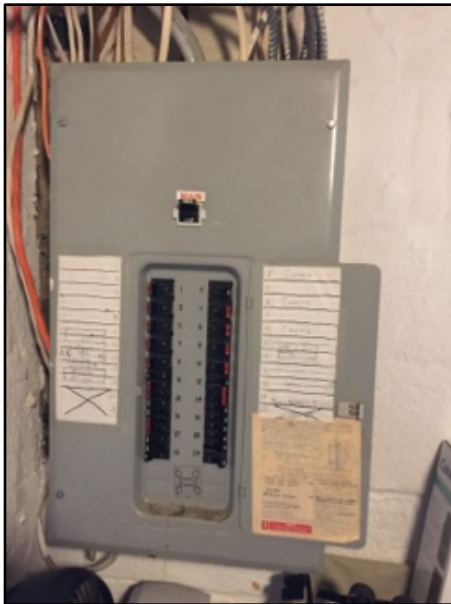
Figure 40-1

The home is equipped with a Federal Pacific Electric (FPE) Stab-lok brand electrical panel. Stab-lok load centers and their components are considered problematic by industry professionals due to their high failure rate as documented by the Consumer Products Safety Commission. Failure of any component within the electrical system may result in fire and/or electrocution. I highly recommend replacement by a licensed electrician. For more information on FPE panels, consult: <http://www.ismypanelsafe.com/fpe.php>

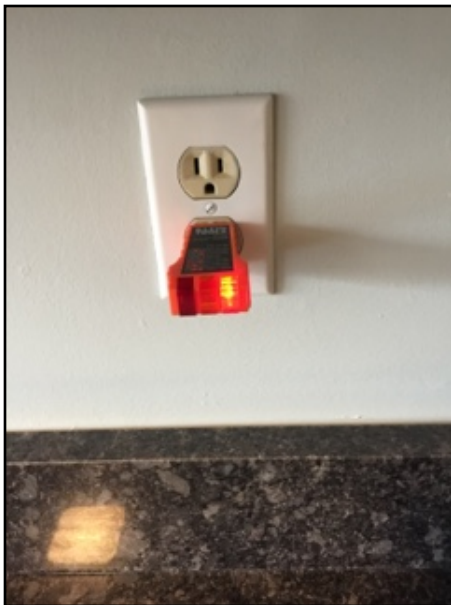
Figure 41-1

Many homes have a "rogue" receptacle here and there. This could be from a defective installation, a defective piece of material, or just wear and tear. A wide variety of defects can be discovered with a standard tester.

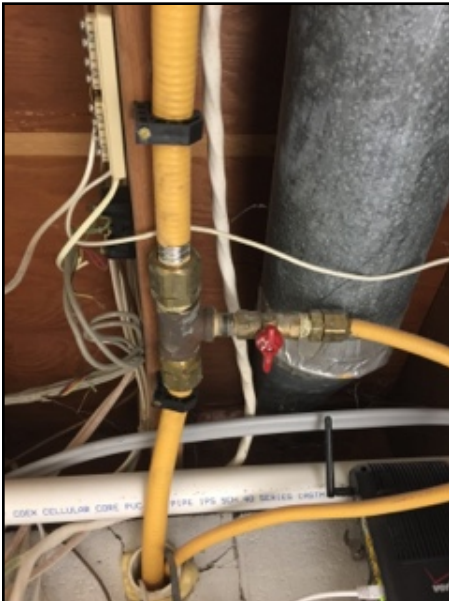
Figure 43-1

Per the Maryland State Standards of Practice, we are required to report on the presence of Corrugated Stainless Steel Tubing (CSST), with the recommendation that the bonding be reviewed by a licensed master electrician.

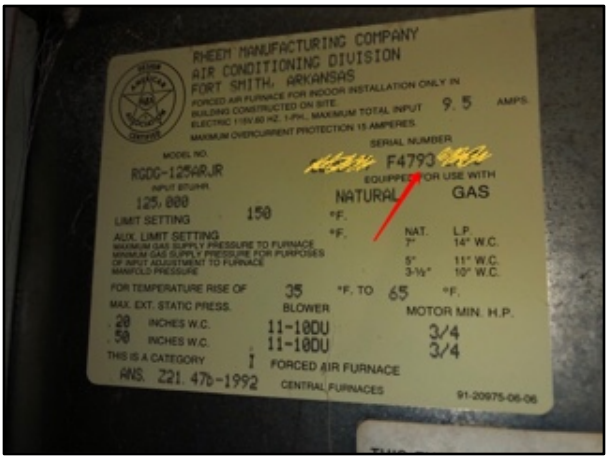
Figure 45-1

Comment 45:  
Many manufacturers hide the manufacture date within their equipment's serial number. Rheem is no different, and we have deduced that this unit is 27 years old. 15-25 years is the typical life expectancy for a furnace.

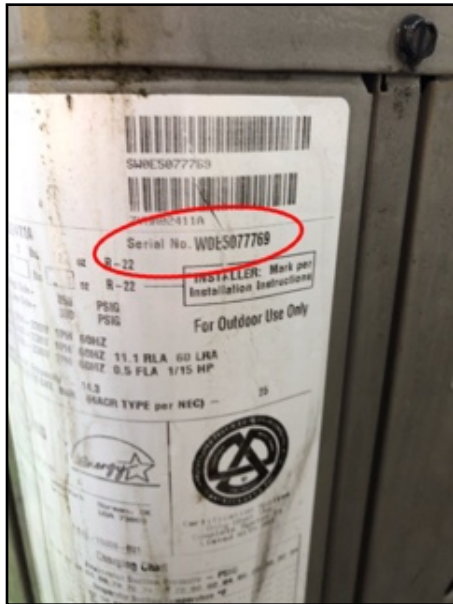
Figure 49-1

The location and orientation of the HVAC unit can lead to different levels of wear. These 2 units, at the same home, show drastically different levels of wear on the labels, but were manufactured in the same year (2005). Any time a unit is beyond its serviceable life, we suggest further evaluation from a qualified professional.

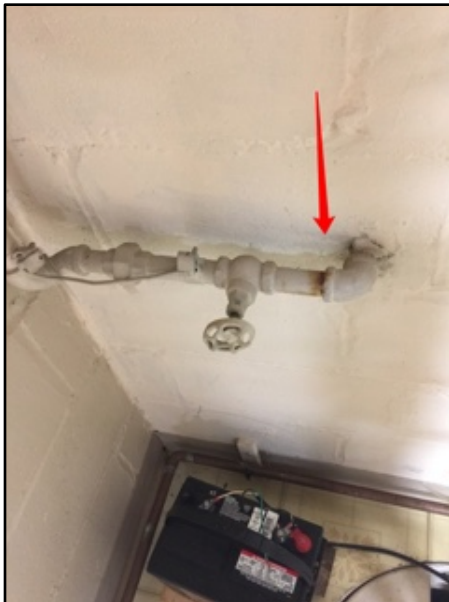
Figure 51-1

The water service piping, and some of the nearby piping in the basement, is galvanized steel. Galvanized steel rusts, but it starts on the inside of the pipe, and at joints. While no leaks were noted at the time of inspection, including the rust spot indicated by the arrow, we still suggest further evaluation from a qualified professional.

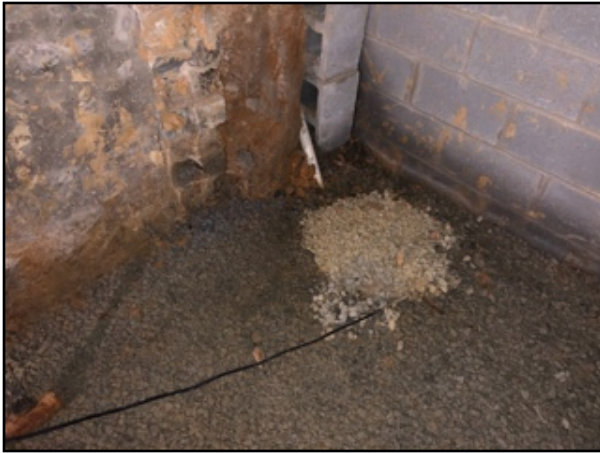
Figure 53-1

Sump pump lid was covered with gravel. Upon removing the lid, it was discovered that the discharge pipe has disconnected from the pump outlet. We suggest repair from a qualified professional.

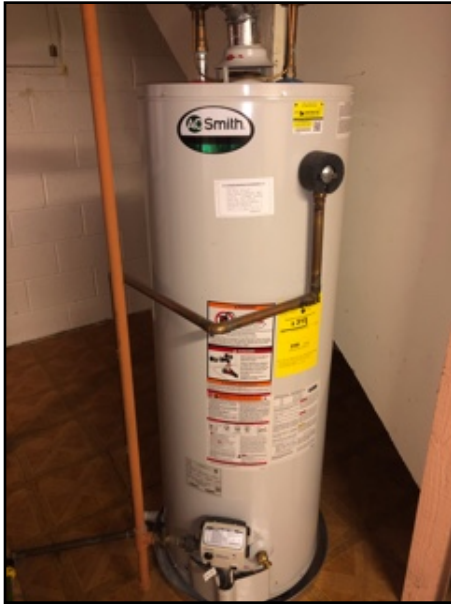
Figure 56-1

Temperature & Pressure Relief Valves (TPRVs) are notorious for leaking once opened. Modern units are specified to be replaced regularly. We suggest further evaluation from a qualified professional.

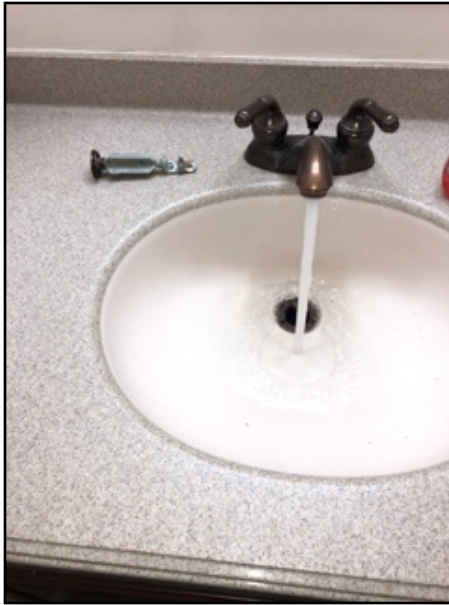
Figure 61-1

The stopper for the sink was found next to the sink, not installed. When placed into the drain, the stopper would not come back up. We suggest repair from a qualified professional.

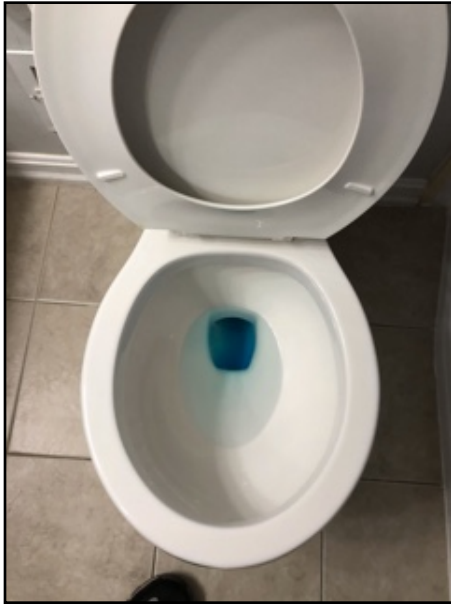
Figure 62-1

A dye tablet was placed in the tank of the toilet. After some time, dye was observed leaking from the tank into the bowl. The most likely culprit is a leaking flapper, but we suggest further evaluation from a qualified professional.

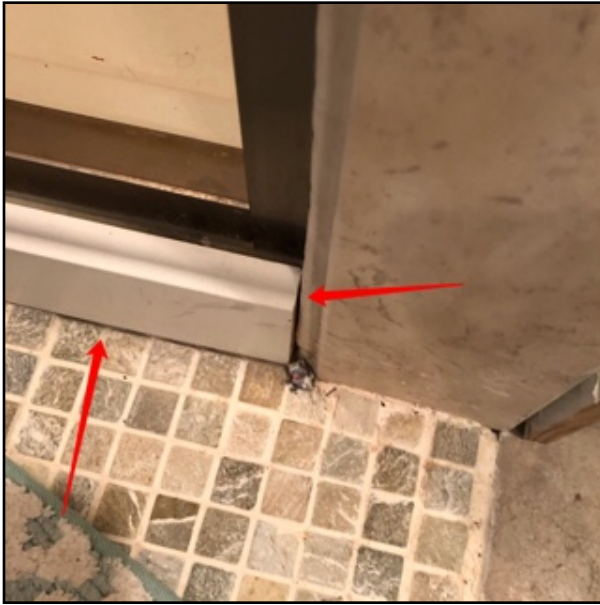
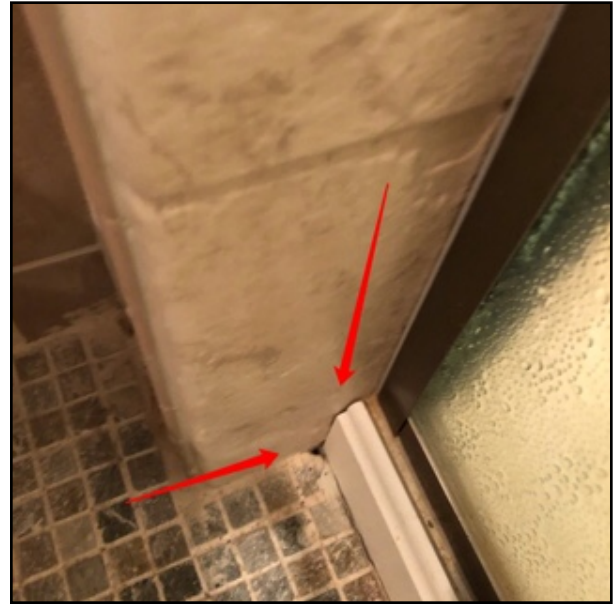
Missing caulking around trim work can allow moisture intrusion. We suggest further evaluation and repairs by a qualified professional.

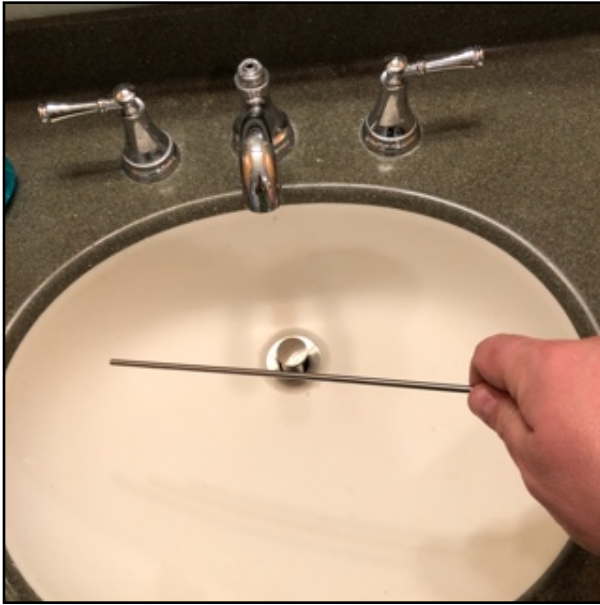
Figure 65-1

Stopper actuator rod not attached. We suggest further evaluation and repairs by a qualified professional.

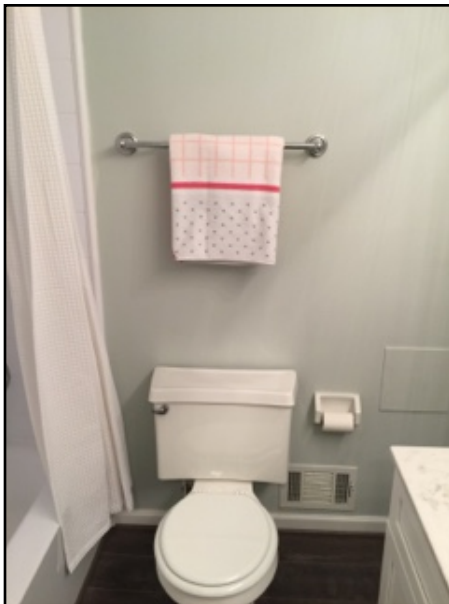
Figure 66-1

The toilet bowl was loose from the flange, and the toilet tank was loose from the bowl. We suggest further evaluation from a qualified professional.

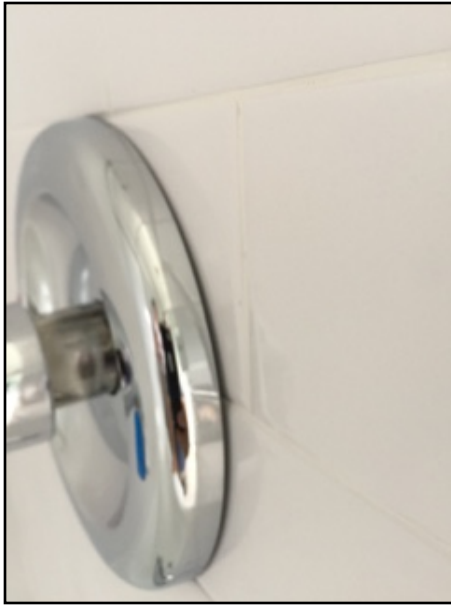
Figure 67-1

No caulk at the faucet trim. This is a source of moisture intrusion. We suggest further evaluation and repair by a qualified professional.

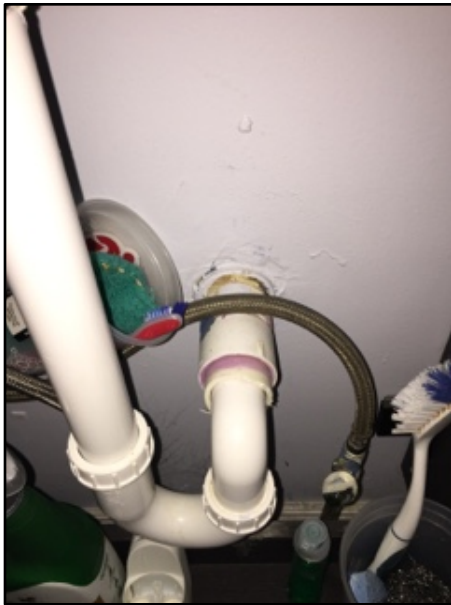
Figure 68-1

Drain connection not made in a professional manner. We suggest further evaluation and repair by a qualified professional.

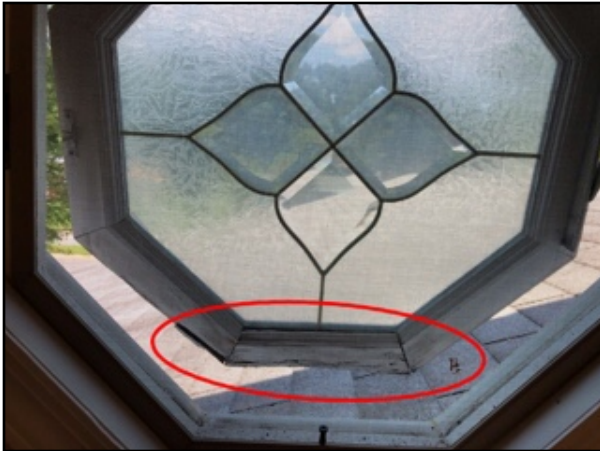
Figure 69-1

The trim around the window has gaps and cracks and has taken on some moisture damage. This damage can allow moisture to further penetrate if not remedied. We suggest further evaluation and repairs from a qualified professional.

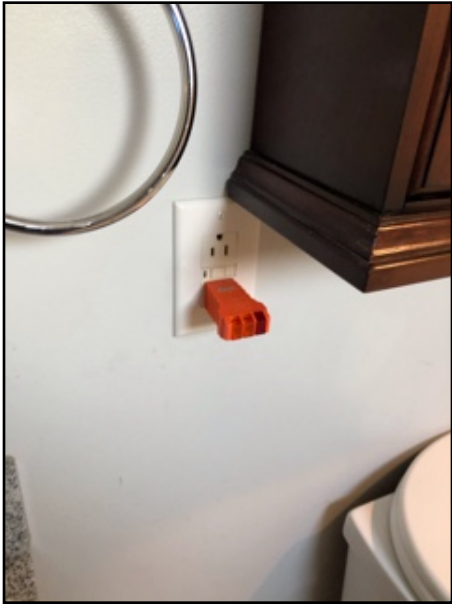
Figure 70-1

No power was available to these receptacles. All breakers were checked, and all GFCIs were reset. We suggest further evaluation and repairs by a qualified professional.

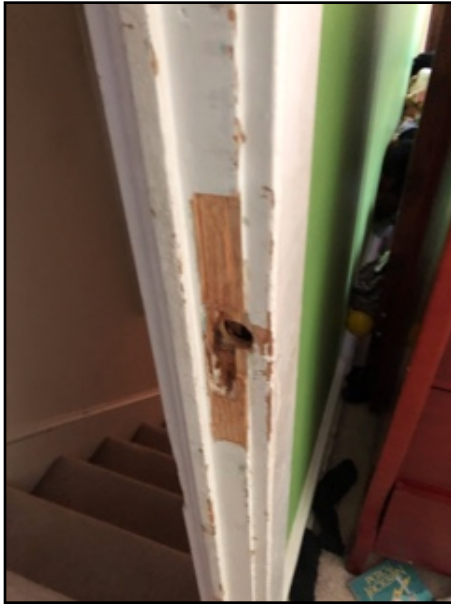
Figure 76-1

The door to the bedroom has been damaged. Repairs have been made, and the door is still functional. We suggest installing a strike plate on the jamb, filling gaps with wood filler, sanding and painting to ensure optimum function and aesthetics.

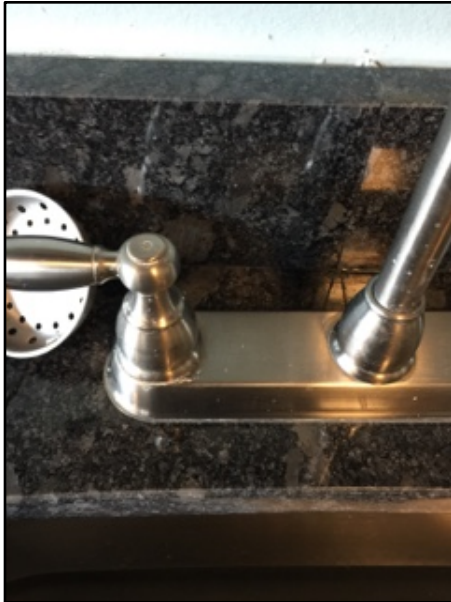
Figure 77-1

The kitchen faucet has been installed backwards. The cold side should be on the right, and this allows the model number (second picture) to remain hidden. We suggest repair by a qualified professional.

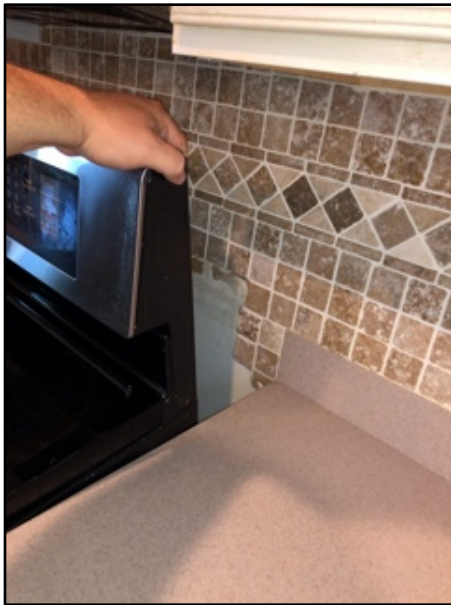
Figure 78-1

The #1 issue with ranges is that the anti-tip bracket is not installed, or installed improperly. The anti-tip bracket anchors a rear foot of the range to the ground. In the event that the oven door is ever used as a stepping stool (kids love to climb), the anti-tip bracket will prevent the range from leaning forward, and possibly tipping over.

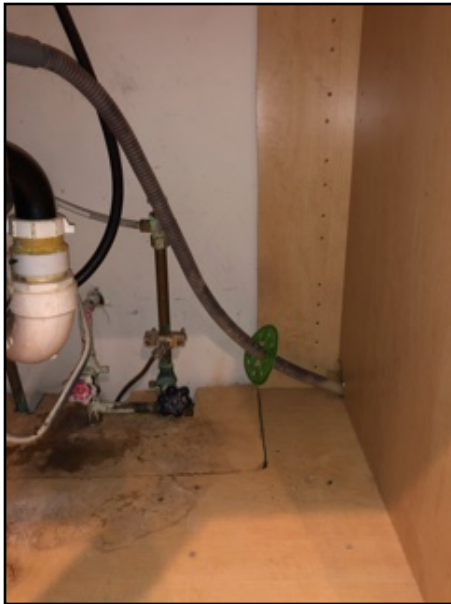
Figure 79-1

A lot of sludge and debris was noted in the dishwasher discharge. Traditionally, these hoses needed to be installed with a "high loop" in order to drain off properly. Newer models of dishwasher do not always need this installation. We suggest further evaluation from a qualified professional.

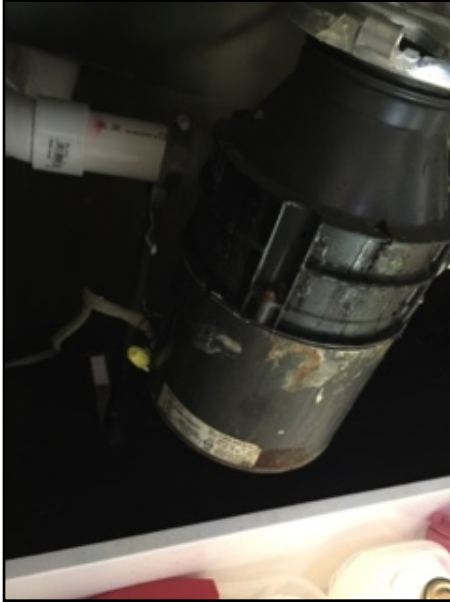
Figure 80-1

Disposal had exterior corrosion, and a wire nut was coming out of the bottom. We suggest repairs by a qualified professional.

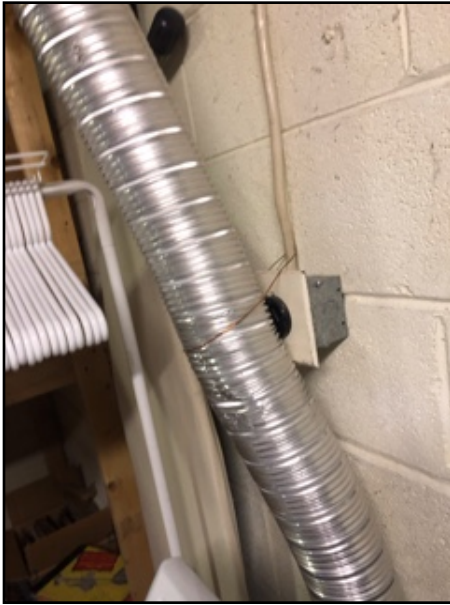
Figure 82-1

The dryer vent is tethered to an electrical outlet with a piece of bare copper wire, and the trim on the exterior is loose.

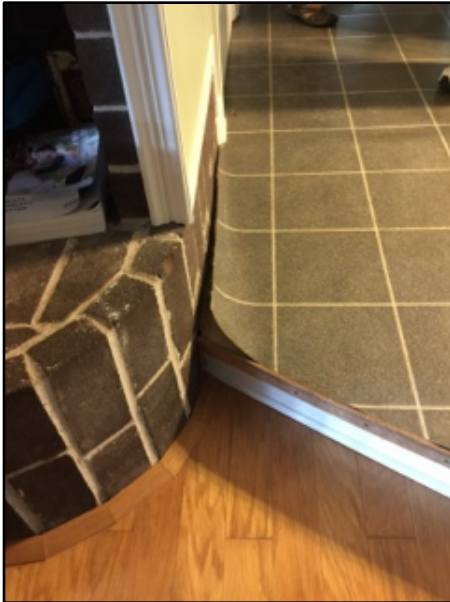
Figure 84-1

Vinyl flooring in kitchen is starting to peel back. We suggest further evaluation and repair by a qualified professional.

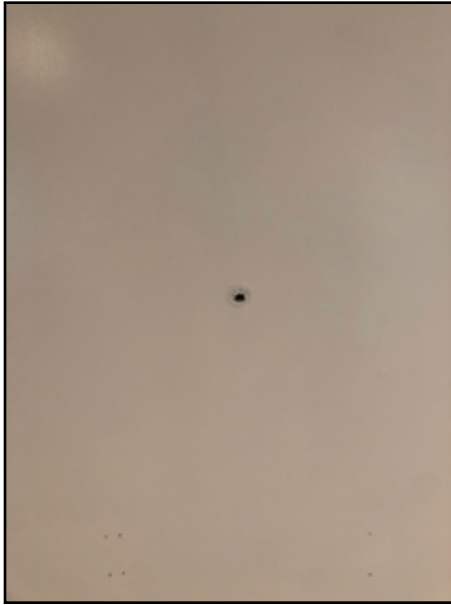
Figure 85-1

Any home that isn't brand new is likely to have holes from hangers, settlement cracks, and other minor imperfections in the walls. In all 3 of these cases, the damage to the wall is cosmetic.

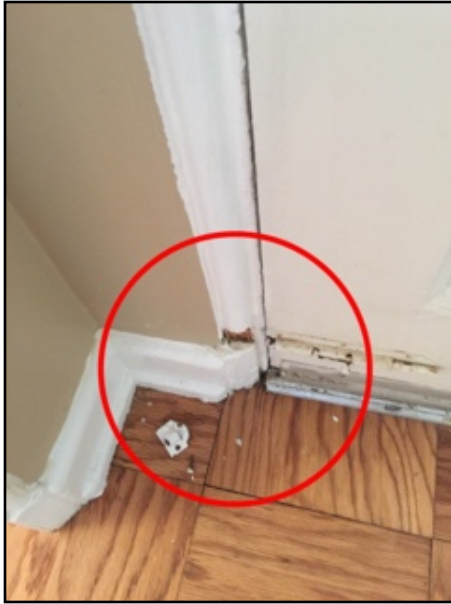
Figure 86-1

The rear egress door, located in the kitchen, had a damaged latch at the time of inspection. We suggest repairs by a qualified professional.
