# FG Home Inspections

## SAMPLE Home Inspection Report

**123 Sample Street**

Inspected on: Mon, Sep 7 2020 at 9:00 AM

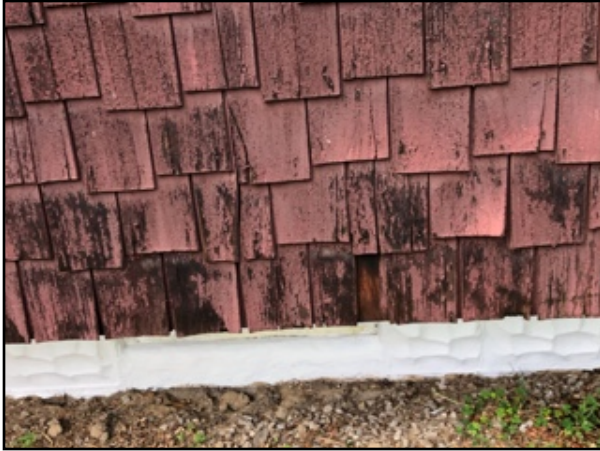
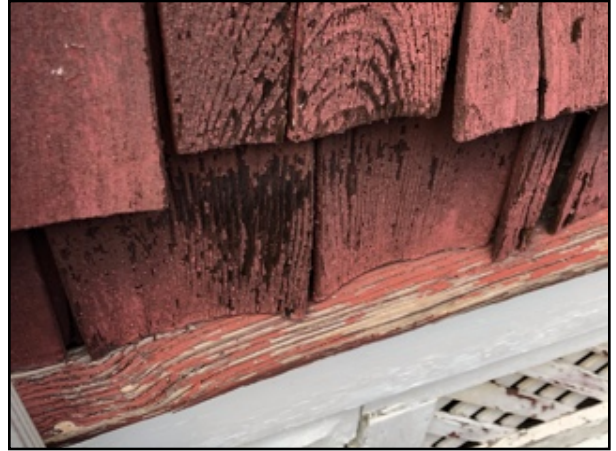
Many of the wood shakes are weathered, damaged, loose, or displaced. There are many opportunities for moisture and/or pest intrusion. We suggest further evaluation and/or repairs from a qualified professional.

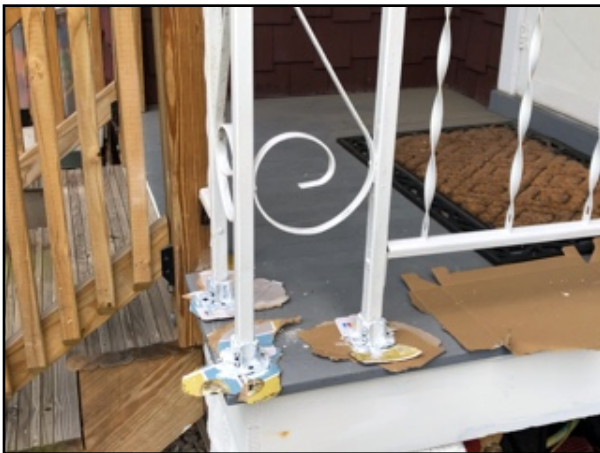
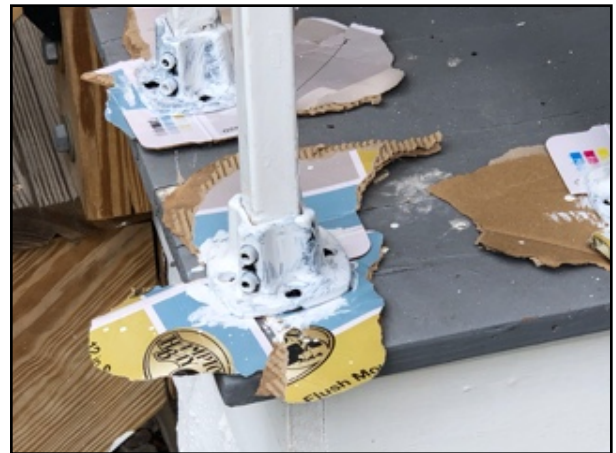
**Comment 13:**

Railings were not secured at the time of inspection, due to painting/renovation. Ensure that all railings are secured when painting is complete.

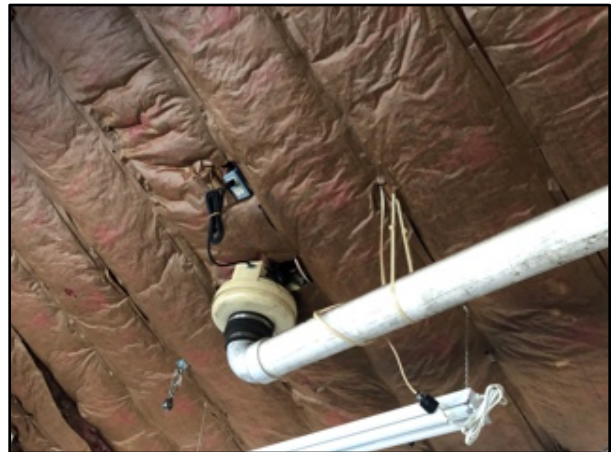
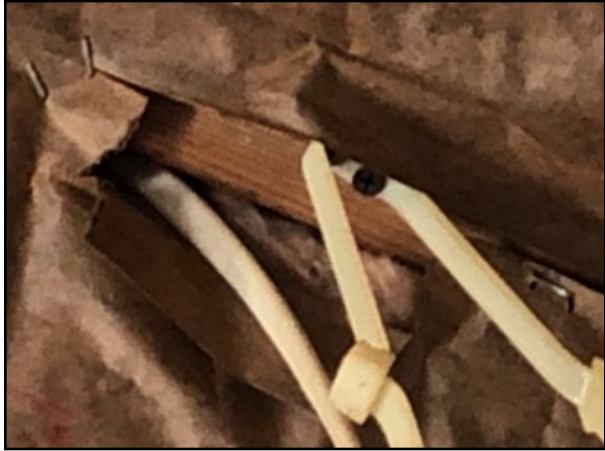
Radon mitigation piping is secured with "zip ties", several of which have been penetrated by fasteners. We recommend the replacing of the piping supports with approved strapping/fasteners.

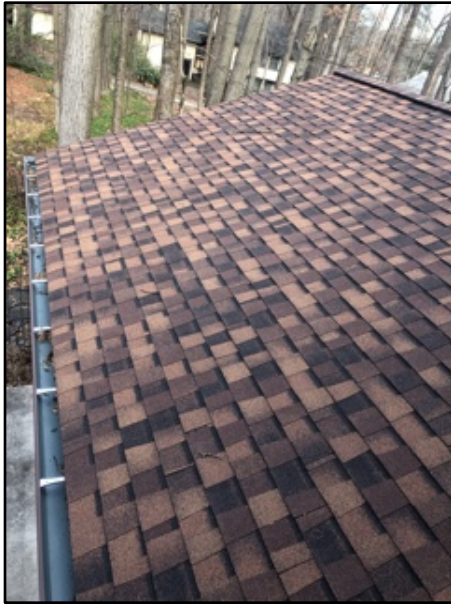
Figure 15-1

This is an example of a roof that has been installed well, and is in excellent condition.

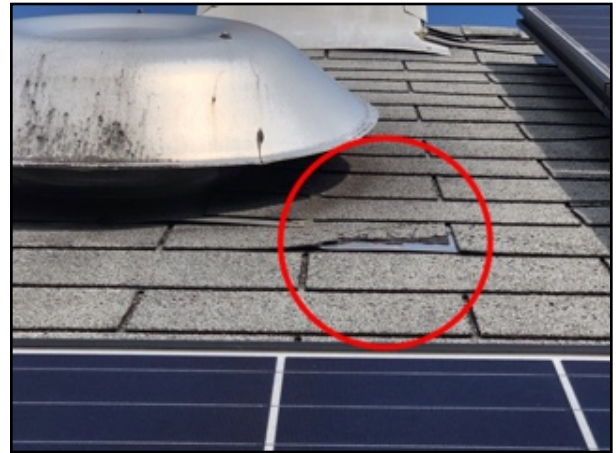
Figure 16-2

These asphalt shingles have been damaged, as indicated. We suggest further evaluation from a qualified professional.

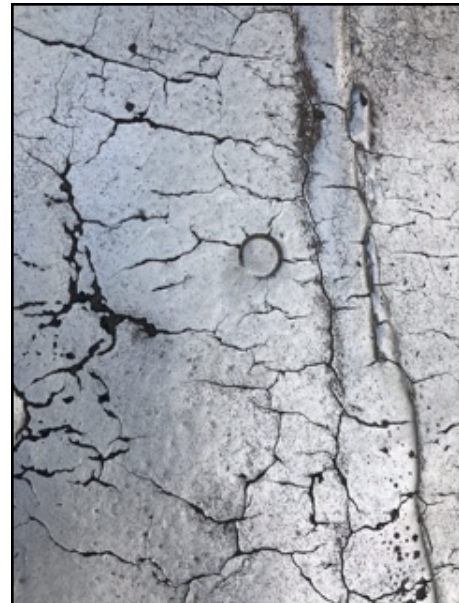
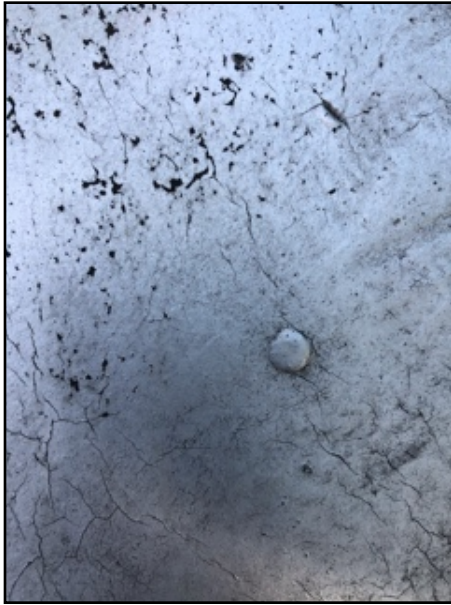
Commonly referred to as "Alligator" or "Crocodile" cracking, due to its appearance, minor cracks are to be expected over time on flat roofs. These cracks are points for moisture intrusion, especially around fasteners. We suggest further evaluation from a qualified professional.

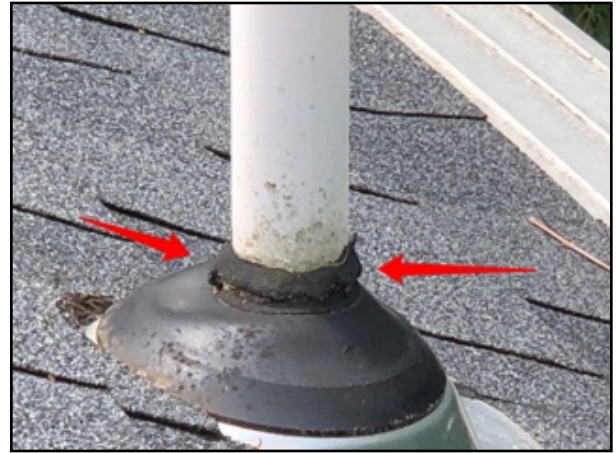
Figure 18-2

The seal around the cast iron vent penetration was not done in a professional manner. The seal around the PVC vent penetration is weathered and worn. In both cases, there is ample opportunity for moisture intrusion. We suggest further evaluation and repair from a qualified professional.

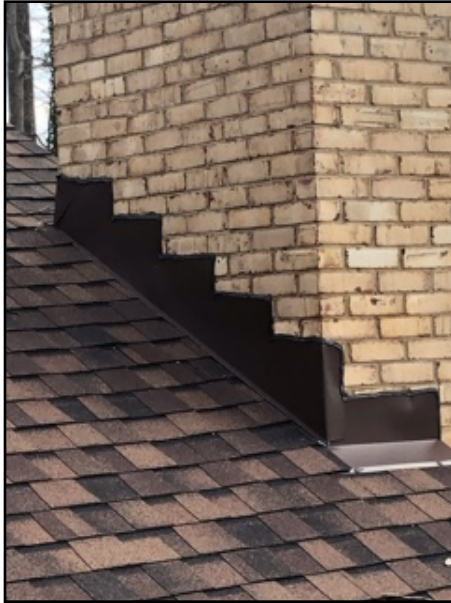
Figure 23-1

The flashing on this chimney was done well.

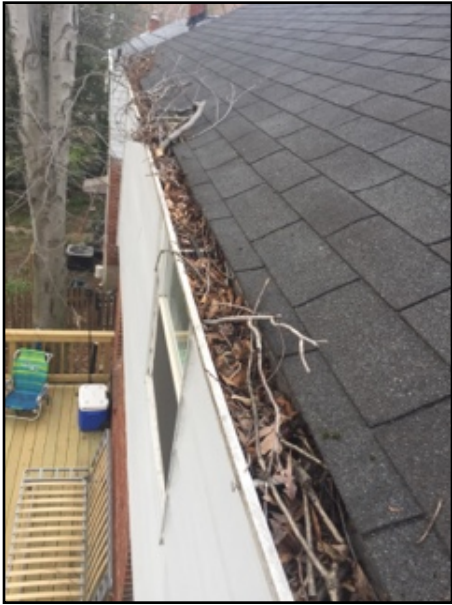
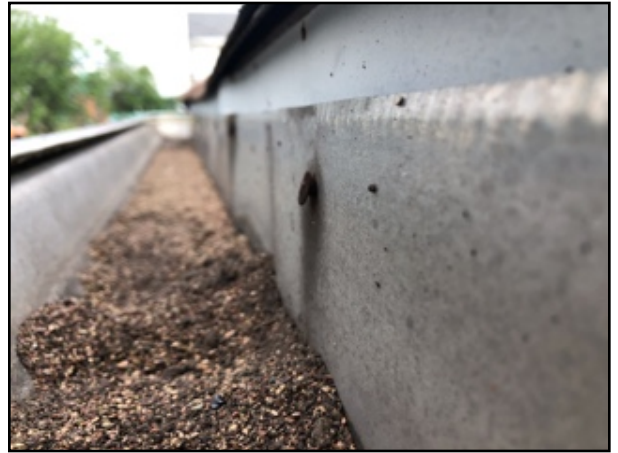
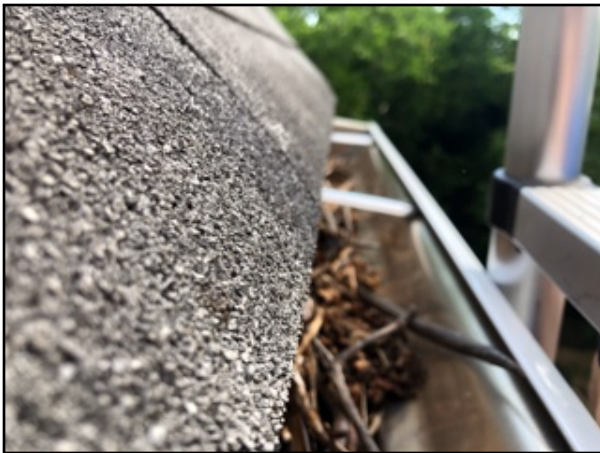
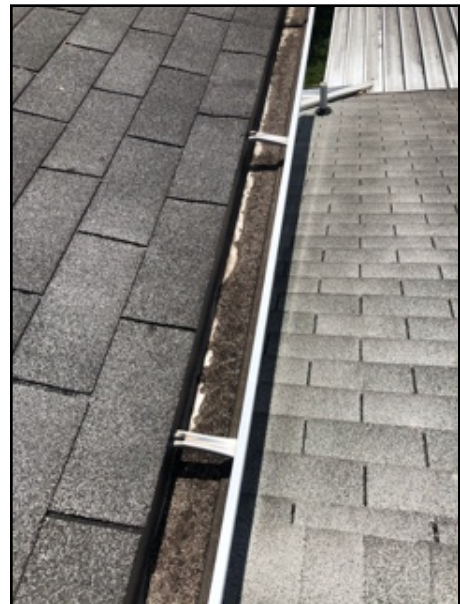
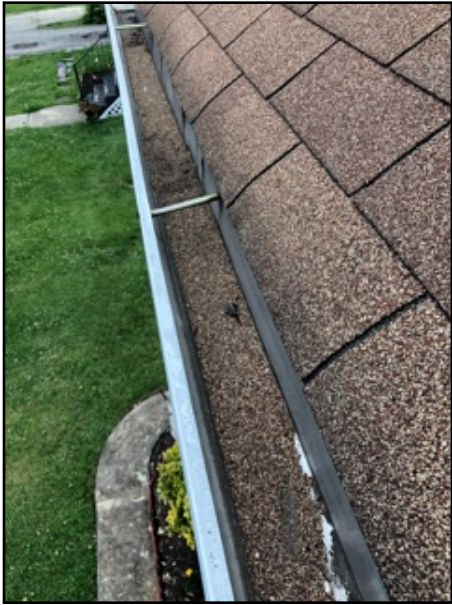
All these pictures were from different homes, and illustrate the importance of keeping your gutters free of debris. Even if you do not live near any trees, granules that detach from asphalt shingles can build up in gutters.

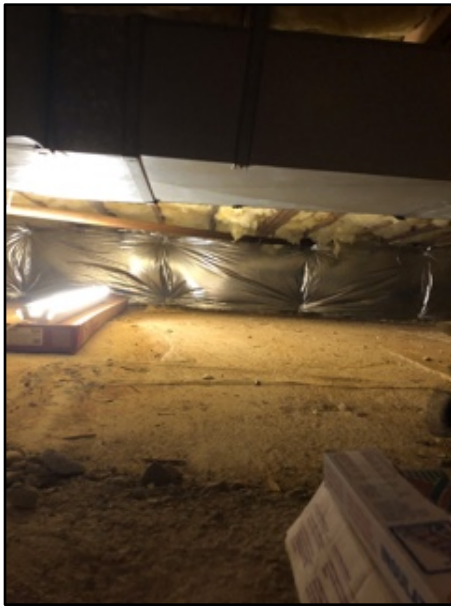
Figure 28-1

This crawlspace was tight, but it was dry, clean, and well-lit.

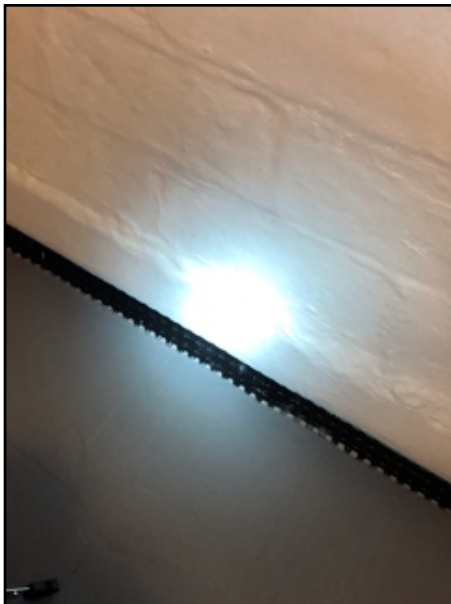
Figure 31-1

Comment 31:  
This perimeter drain was in great shape.

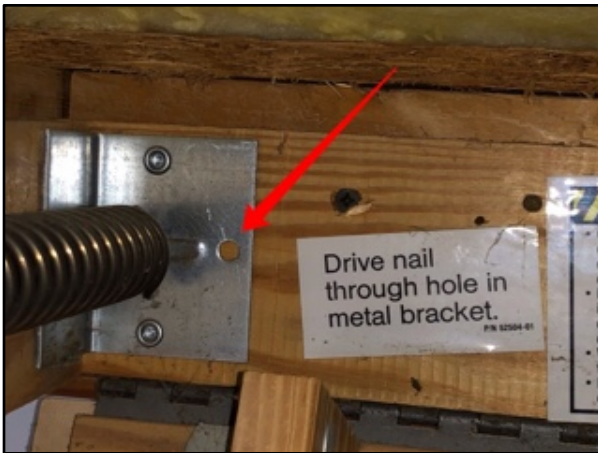
Figure 33-1

Ensure that a nail gets driven through the hole in the metal bracket.

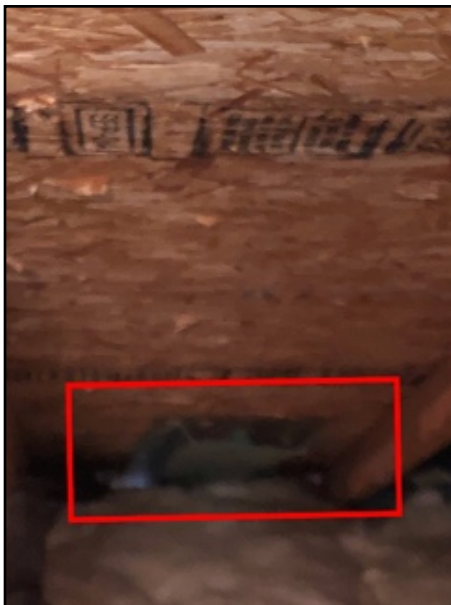
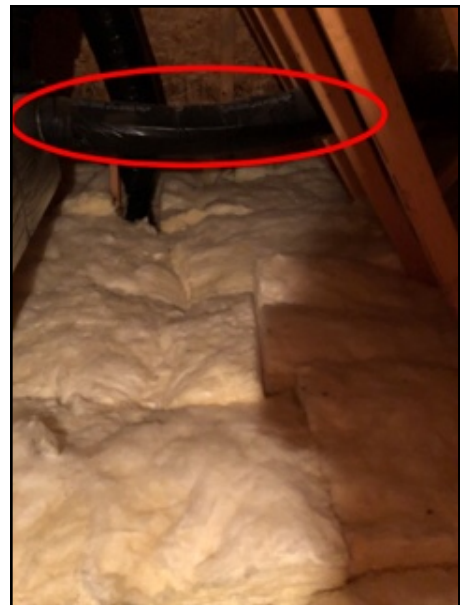
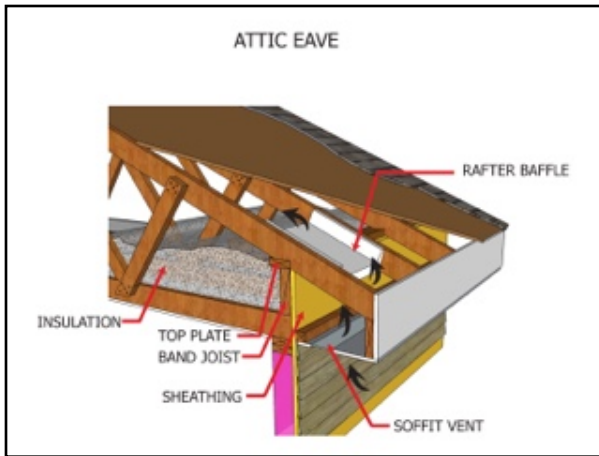
Rafter Baffles, or Vent Risers, are sometimes hard to spot items that are essential for providing a pathway for airflow from the soffit.

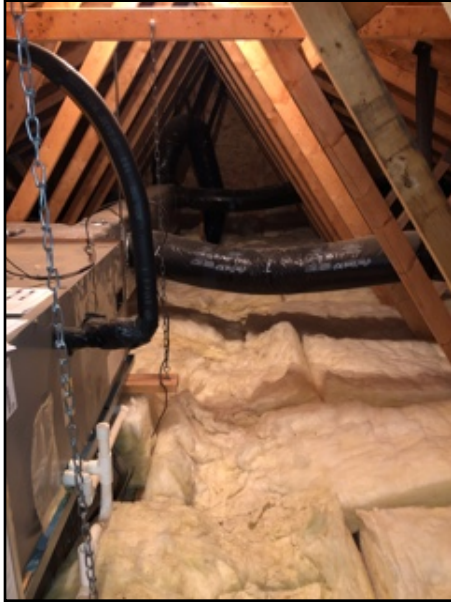
Figure 38-1

Insulation near the air handler has been compressed. Compressed insulation will not perform as well as undisturbed insulation.

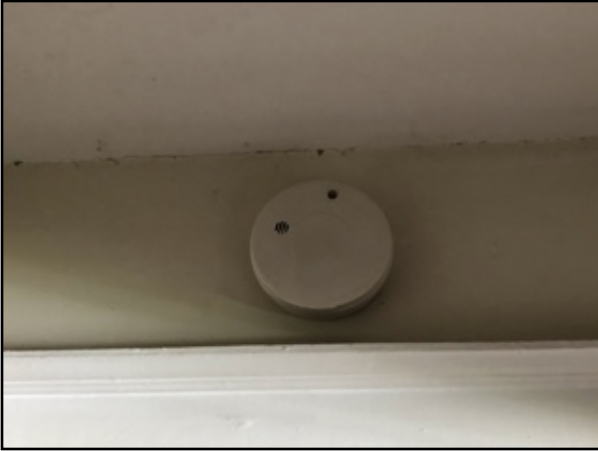
Figure 42-1

Ensure all smoke detectors get regular battery replacements.

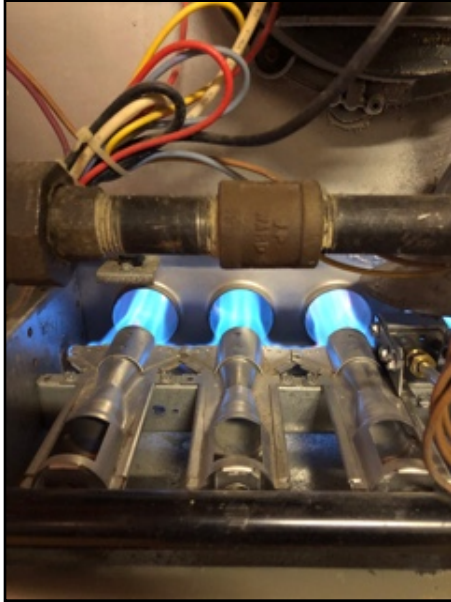
Figure 46-1

An example of a well defined, blue flame. This shows the gas burners for the furnace working, and in good condition.

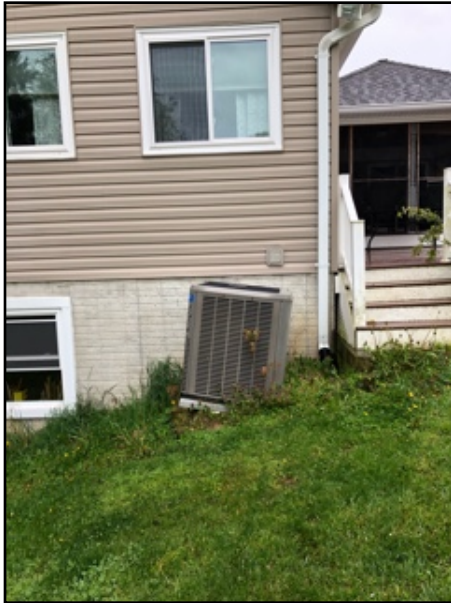
Figure 48-1

The unit on the rear of the home is not level. For proper operation, units should be on a firm, level surface. We suggest further evaluation from a qualified professional.

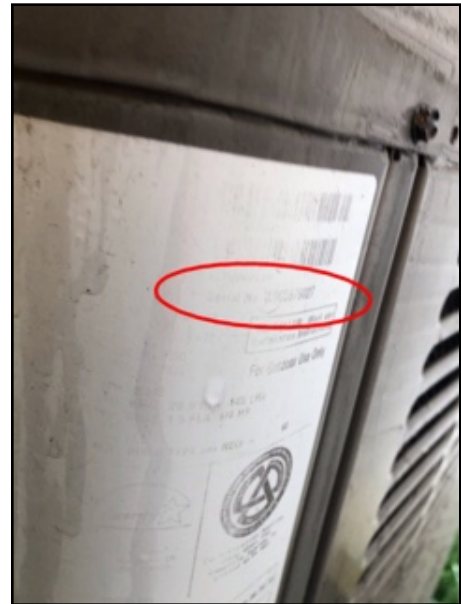
Figure 49-2

The location and orientation of the HVAC unit can lead to different levels of wear. These 2 units, at the same home, show drastically different levels of wear on the labels, but were manufactured in the same year (2005). Any time a unit is beyond its serviceable life, we suggest further evaluation from a qualified professional.

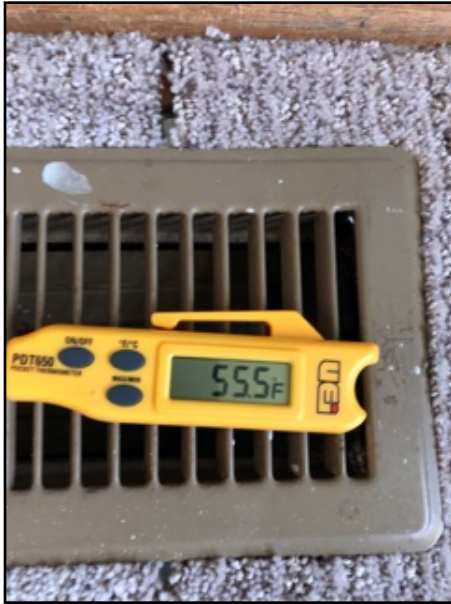
Figure 50-1

Air conditioners over 10 years old and heat pumps over 5 years old should be checked, cleaned and serviced yearly by a licensed contractor.

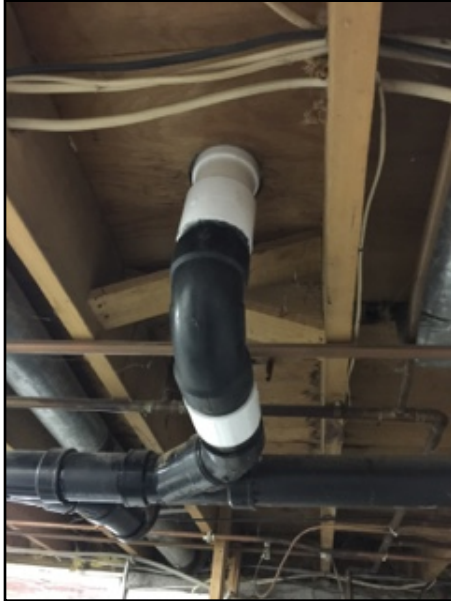
Figure 52-1

PVC and ABS can be joined together, in certain instances. These transitions require a special glue, and the number of transitions may be restricted by local codes. We suggest further evaluation from a qualified professional.

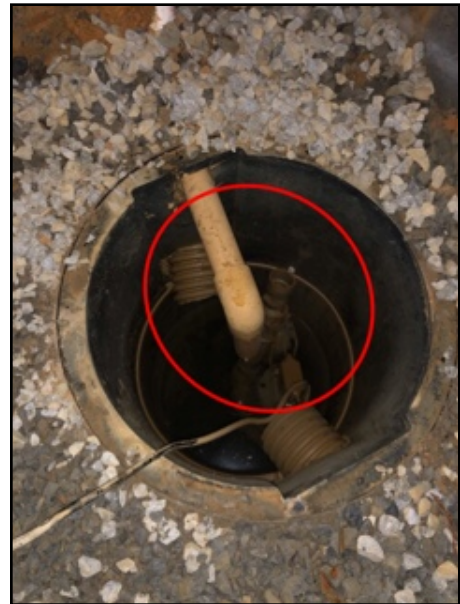
Figure 53-2

Sump pump lid was covered with gravel. Upon removing the lid, it was discovered that the discharge pipe has disconnected from the pump outlet. We suggest repair from a qualified professional.

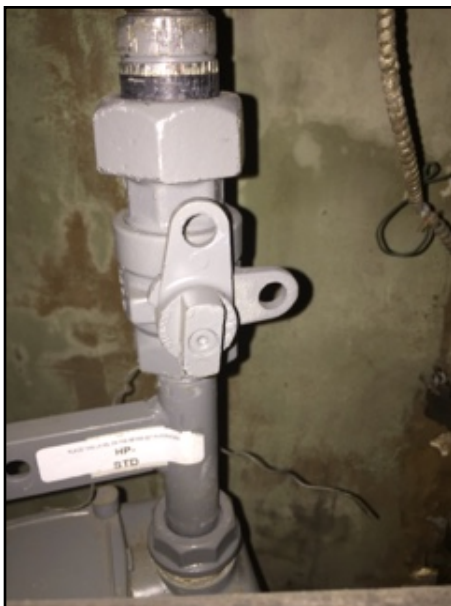
Figure 54-1

Location of the gas shutoff valve. We recommend keeping an adjustable wrench near the meter, in the event of an emergency.

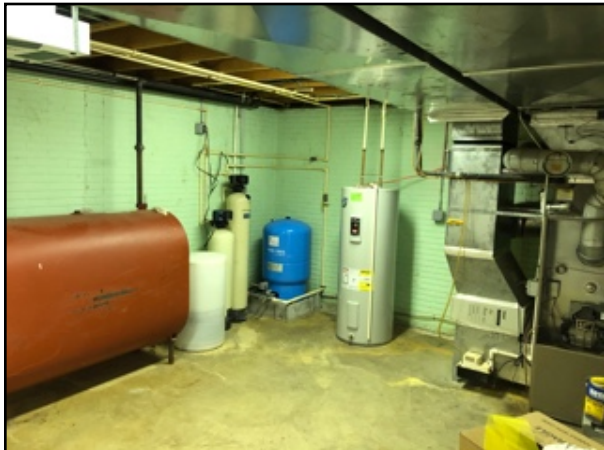
Figure 57-1

This water heater does not have an expansion tank. There is some debate as to the efficiency of an expansion tank on a well system, but we always suggest having your system evaluated and serviced by a qualified professional.

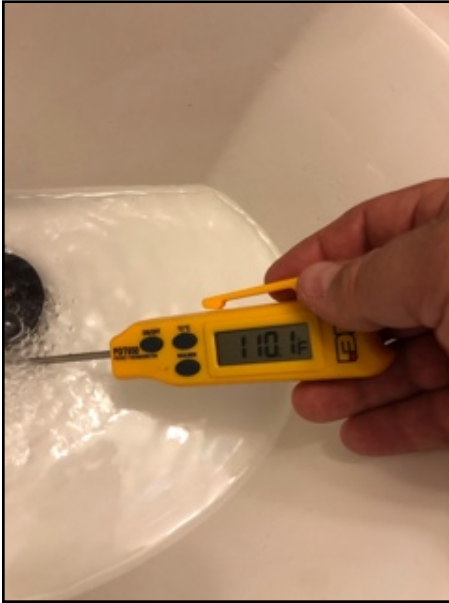
Figure 58-1

**Comment 58:**  
Water temperature is checked at the fixture furthest from the water heater.

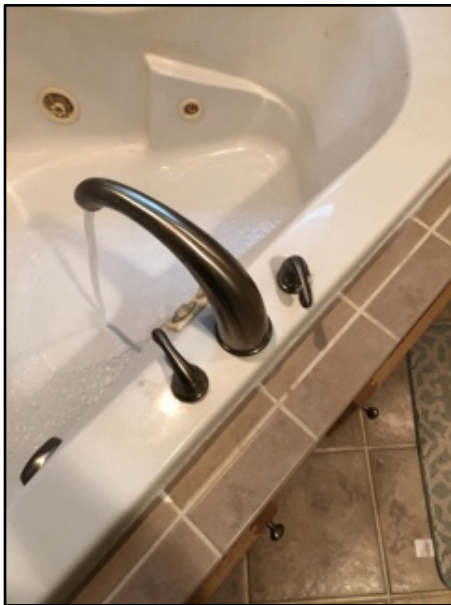
Figure 59-1

Cartridges for these types of tub faucets come in a left and a right variety. This is so that the handles can face the direction of the spout during filling, making it easier and safer for the bather. We suggest further evaluation from a qualified professional.

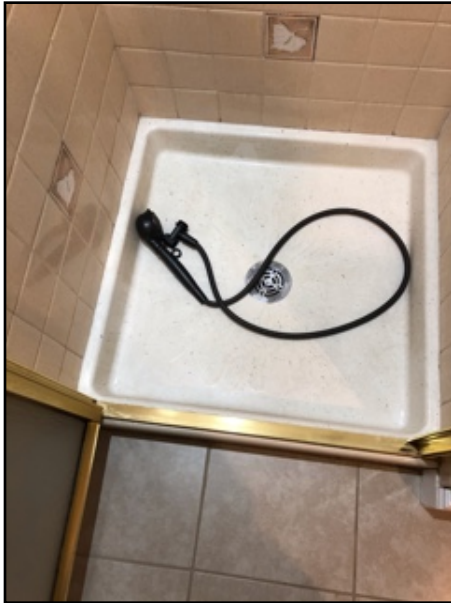
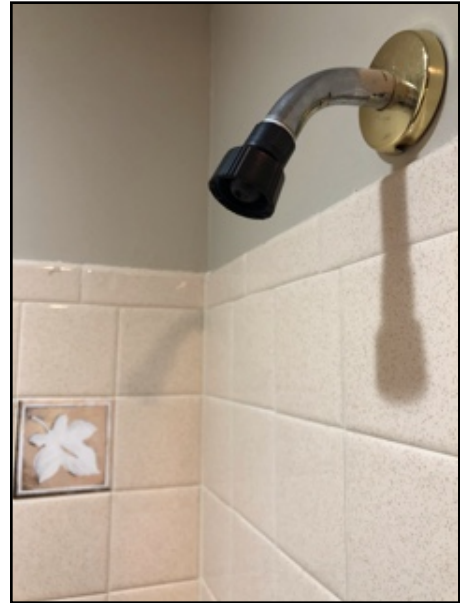
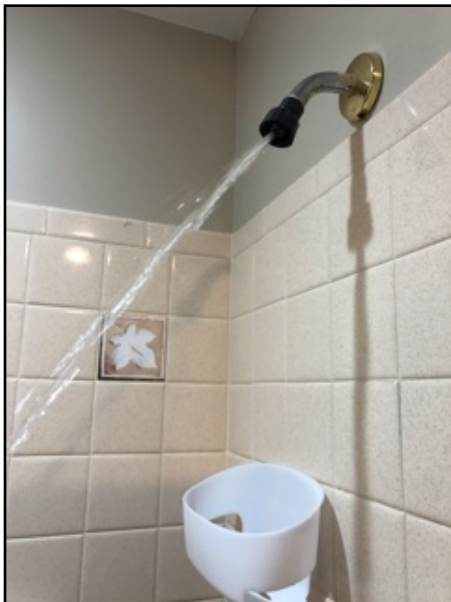
Showerhead not attached at the time of inspection. Water delivery to the shower arm is sufficient. We suggest installation get completed by a qualified professional.

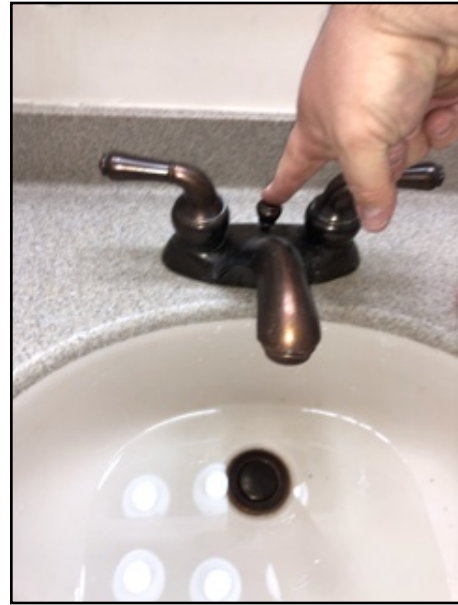
Figure 61-2

The stopper for the sink was found next to the sink, not installed. When placed into the drain, the stopper would not come back up. We suggest repair from a qualified professional.

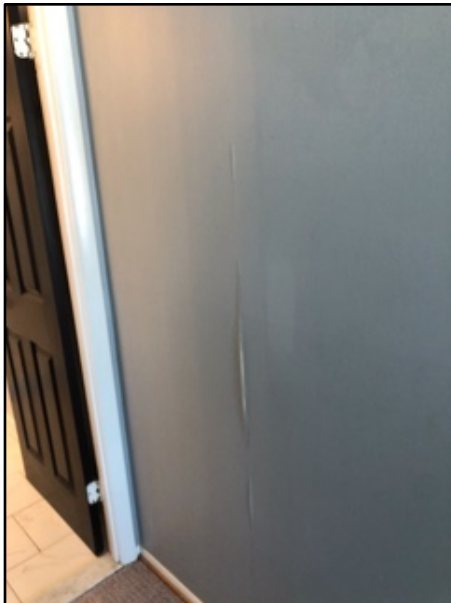
Figure 71-1

Wallpaper near the connected bathroom is starting to peel at one of the seams.

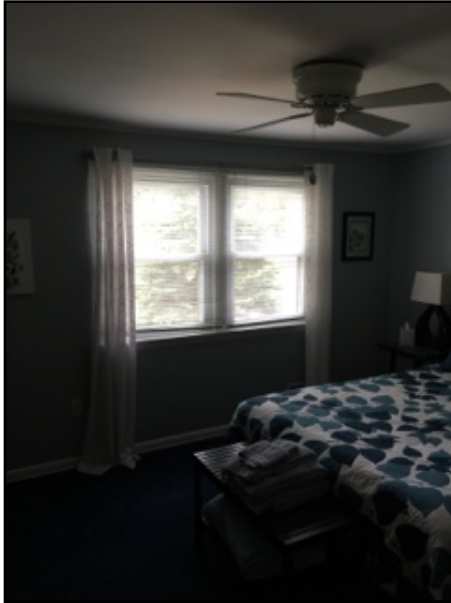
Figure 72-1

Comment 72:  
Ceiling fan is very wobbly.

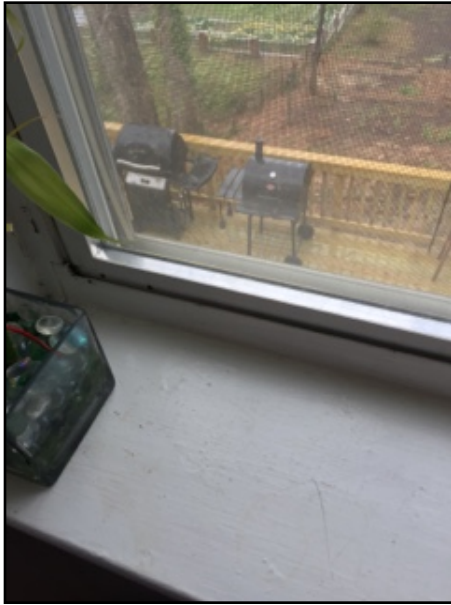
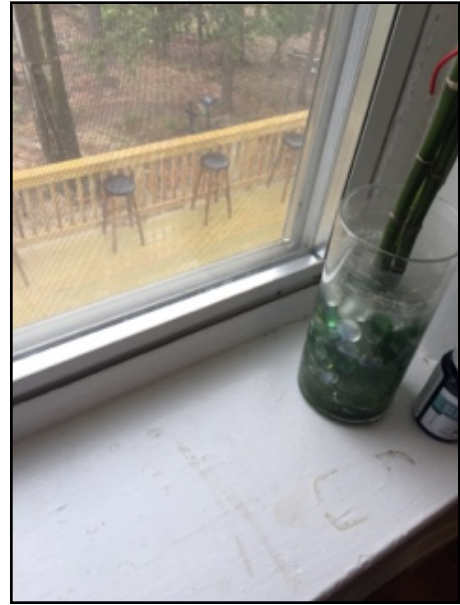
Comment 73:  
While all windows did open, several in the Primary Bedroom were a little stiff and sticky. We suggest regular maintenance and lubrication to ensure optimum performance.

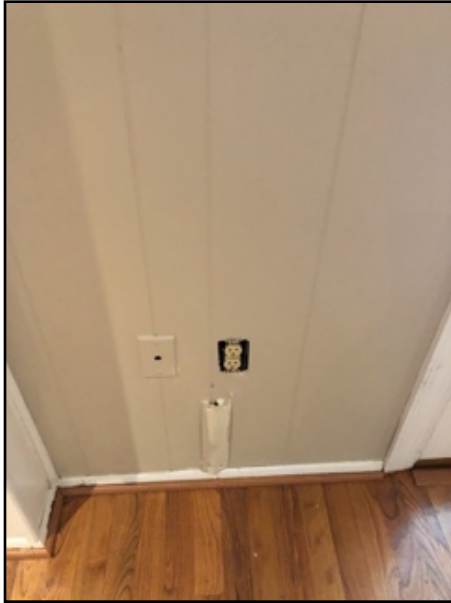
Figure 74-1

Receptacle on back wall does not have a cover.

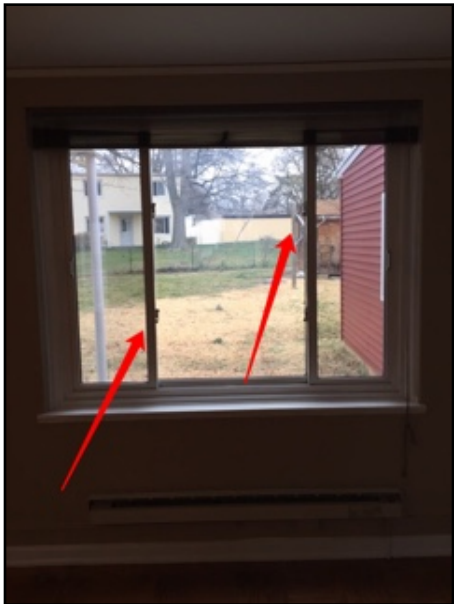
Figure 75-1

The latch on the upper right would not hold at all, and would just swing freely. The latch on the lower left was incredibly stiff. The other two latches operated fine. We suggest further evaluation from a qualified professional.

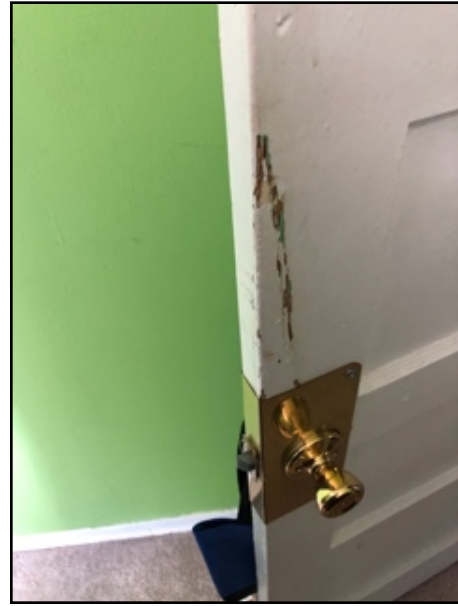
Figure 76-2

The door to the bedroom has been damaged. Repairs have been made, and the door is still functional. We suggest installing a strike plate on the jamb, filling gaps with wood filler, sanding and painting to ensure optimum function and aesthetics.

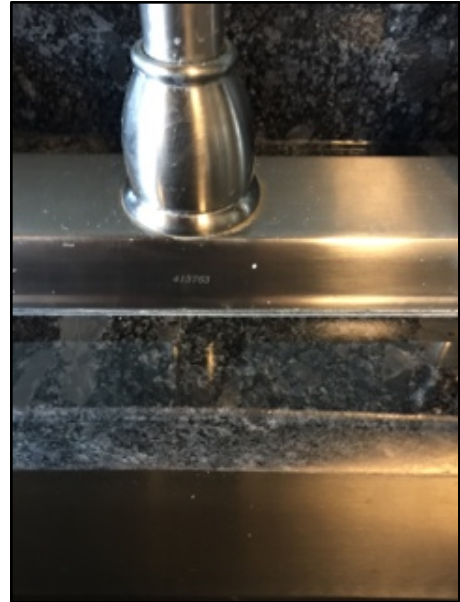
Figure 77-2

The kitchen faucet has been installed backwards. The cold side should be on the right, and this allows the model number (second picture) to remain hidden. We suggest repair by a qualified professional.

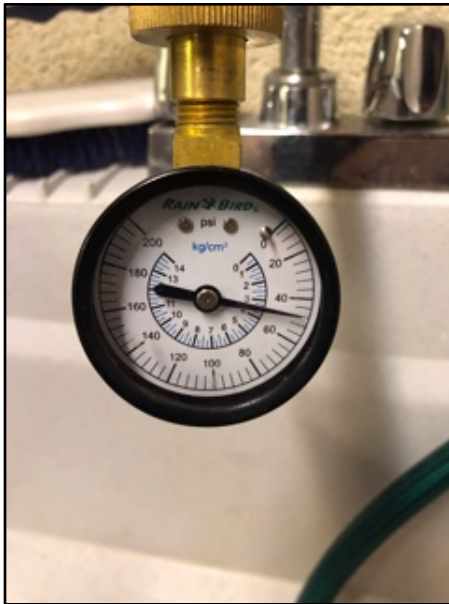
Figure 81-1

Whenever possible, water pressure readings are taken from the laundry sink, rather than a hose faucet. Some homes have pressure reducing valves, but have the hose faucets on unreduced pressure. Taking the pressure reading at the laundry sink gives the most accurate reading.
